**BEAUFORT COUNTY
HISTORIC SITES SURVEY - 1997**

INTENSIVE LEVEL BUILDING INVENTORY FORM

Site Number: U- 13 - 430
Access County Site #
USGS Quad: 290 Laurel Bay
Doc. Level: Intensive Level-Building

Historic name(s): Burlington Plantation Map Ref.: _____ Tax Number: R100 024 0042 0000
Common name(s): _____ City Block Ref.: _____ Island: _____
Address/location: off Joe Frazier Road City/Vicinity of (vic.) _____
Date: 1920 ca. Alteration date: _____
Ownership: 1. private 2. city 3. county 4. state 5. federal 6. unknown
Category: 1. building 2. site 3. structure 4. object
Historic use(s): Multiple dwelling Current uses: Abandoned

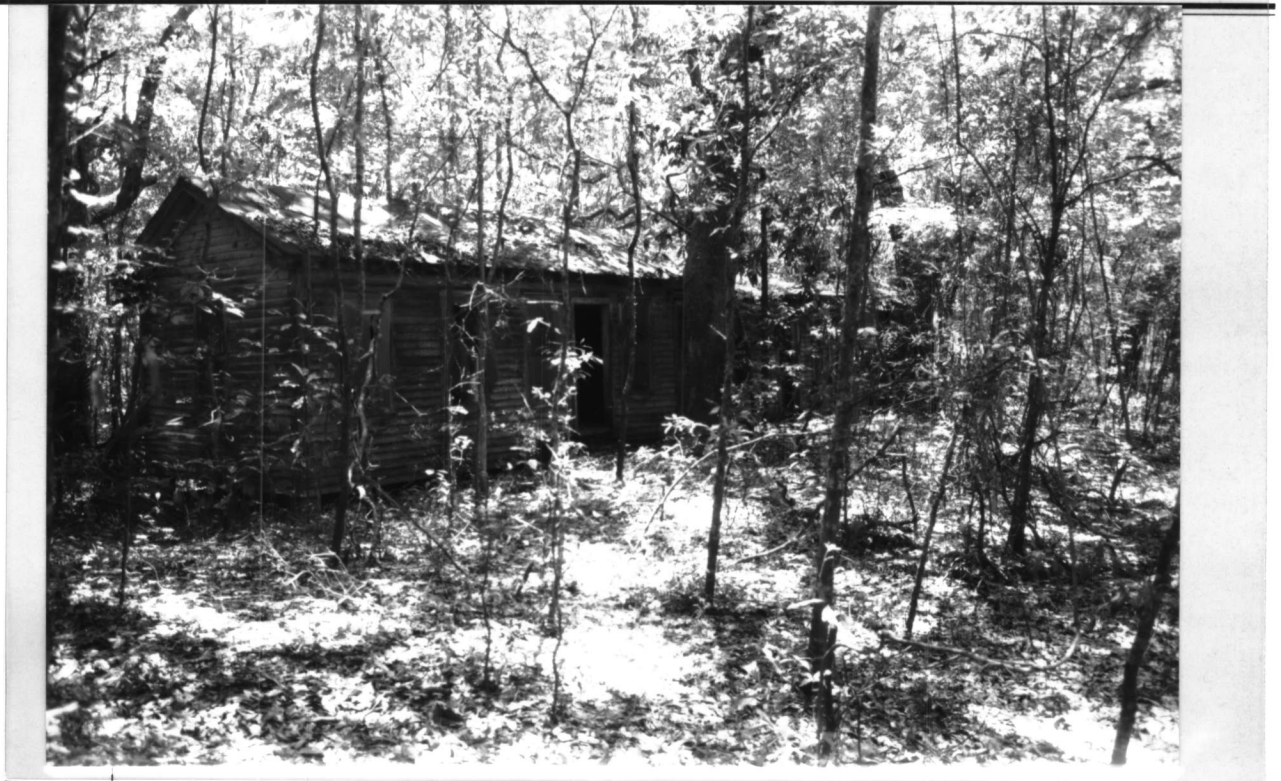
Roll # Neg. View of:
H-11 20 ne oblique

Alterations: Alteration date: _____ Integrity: good Condition: deteriorated

Description: Long narrow building, facade features 8 bays (6 windows and 2 single doors). Facade still stands, but rear has collapsed. Returned eaves on gable ends.
