**BEAUFORT COUNTY
HISTORIC SITES SURVEY - 1997**

INTENSIVE LEVEL BUILDING INVENTORY FORM

Site Number: U- 13 - 0013
Access County Site #

Historic name(s): Corner Packing Shed Map Ref.: _____ Tax Number: R300 016 000 0130 0000
Common name(s): _____ City Block Ref.: _____ Island: St. Helena Is.
Address/location: 875 Sea Island Parkway City/Vicinity of (vic.) St. Helena Island
Date: 1930 ca. Alteration date: _____
Ownership: 1. private 2. city 3. county 4. state 5. federal 6. unknown
Category: 1. building 2. site 3. structure 4. object
Historic use(s): commercial Current uses: abandoned

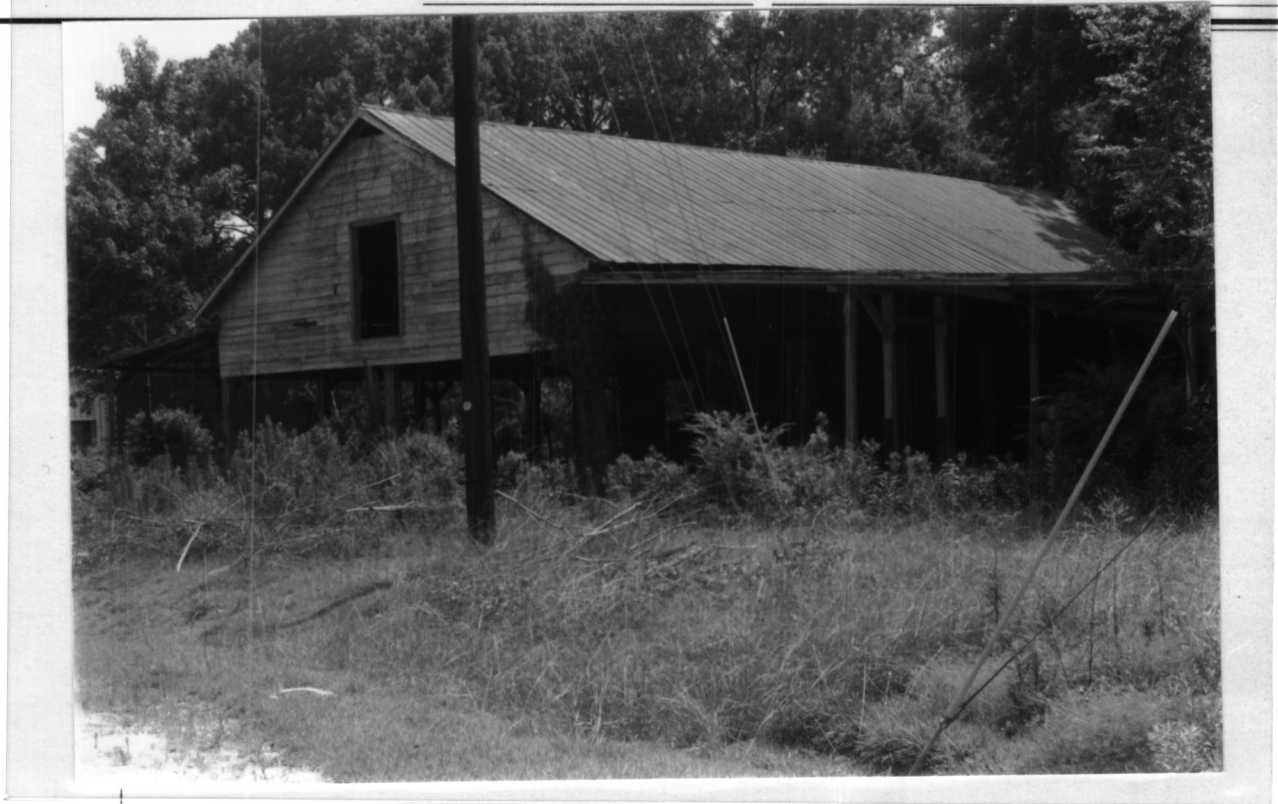
Roll # Neg. View of:
1433 1 sw oblique

Alterations: _____ Alteration date: _____ Integrity: good Condition: fair

Description: Long rectangular shed, gable aisle with shed roof porches on each side. Lower level siding removed, wooden frame supports open; area under gable enclosed in weatherboard. Single door opening in gable.
