**BEAUFORT COUNTY
HISTORIC SITES SURVEY - 1997**

INTENSIVE LEVEL BUILDING INVENTORY FORM

Site Number: U- 13 - 1434
Access County Site #
USGS Quad: 182 Frogmore
Doc. Level: Intensive Level-Building

Historic name(s): Elsie's Store Map Ref.: _____ Tax Number: R300 016 000 0128 0000
Common name(s): _____ City Block Ref.: _____ Island: St. Helena Is.
Address/location: 877 Sea Island Parkway City/Vicinity of (vic.) St. Helena Island
Date: _____ Alteration date: 1950 ca.
Ownership: 1. private 2. city 3. county 4. state 5. federal 6. unknown
Category: 1. building 2. site 3. structure 4. object
Historic use(s): commercial Current uses: commercial

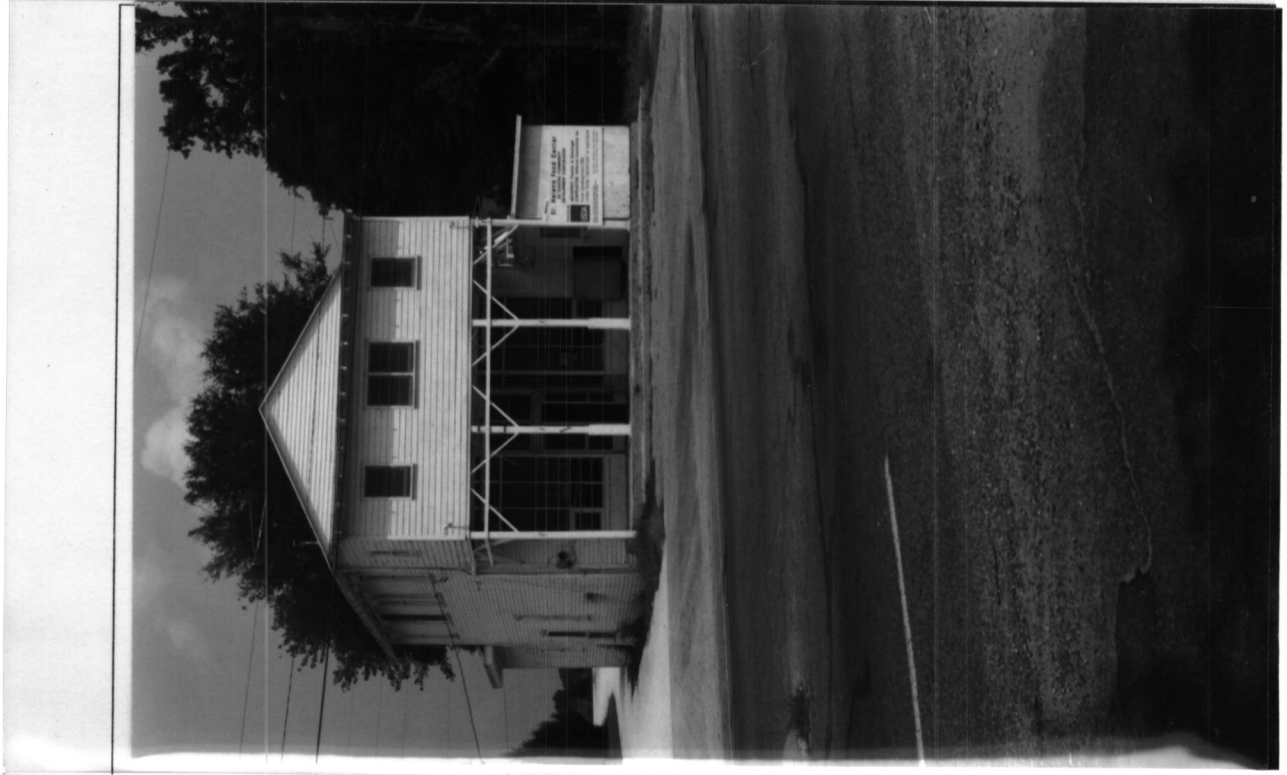
Roll # Neg. View of:
H-19 13 sw oblique

Alterations: Alteration date: 1950 ca. Integrity: fair Condition: good
Second story porch apparently added.

Description: Tall narrow commercial building with a front gable. Second story front porch set on posts with simple diagonal brackets. Wooden staircase along right side reaches to second story.
