**BEAUFORT COUNTY
HISTORIC SITES SURVEY - 1997**

INTENSIVE LEVEL BUILDING INVENTORY FORM

Historic name(s): Croft Praise House Map Ref.: _____ Tax Number: R300 006 000 030A 0000

Address/location: Eddings Point Road City/Vicinity of (vic.) St. Helena Island

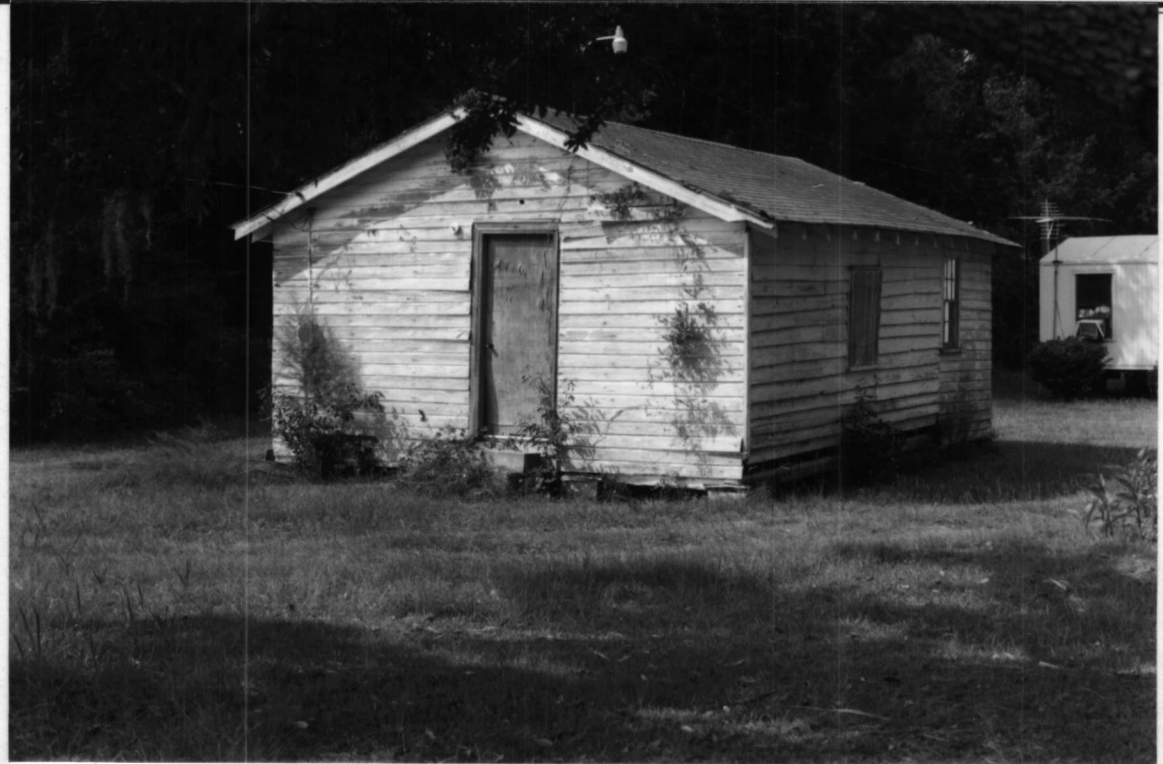
Photograph:

Description: Small (10x25) front building, off center front wooden panel door. Two windows on each long side, one with a wooden casement, the other a 6-pane fixed window.
