**BEAUFORT COUNTY
HISTORIC SITES SURVEY - 1997**

INTENSIVE LEVEL BUILDING INVENTORY FORM

Historic name(s): Eddings Point Community Praise House Map Ref.: _____ Tax Number: R300.010.000.0046.0000
Common name(s): _____ City Block Ref.: _____ Island: St. Helena Is.
Address/location: 219 Eddings Point Road City/Vicinity of (vic.) St. Helena Island
Date: 1900 ca. Alteration date: 1940 ca., 1970 ca.
Ownership: 1. private 2. city 3. county 4. state 5. federal 6. unknown
Category: 1. building 2. site 3. structure 4. object
Historic use(s): Praise House Current uses: religious

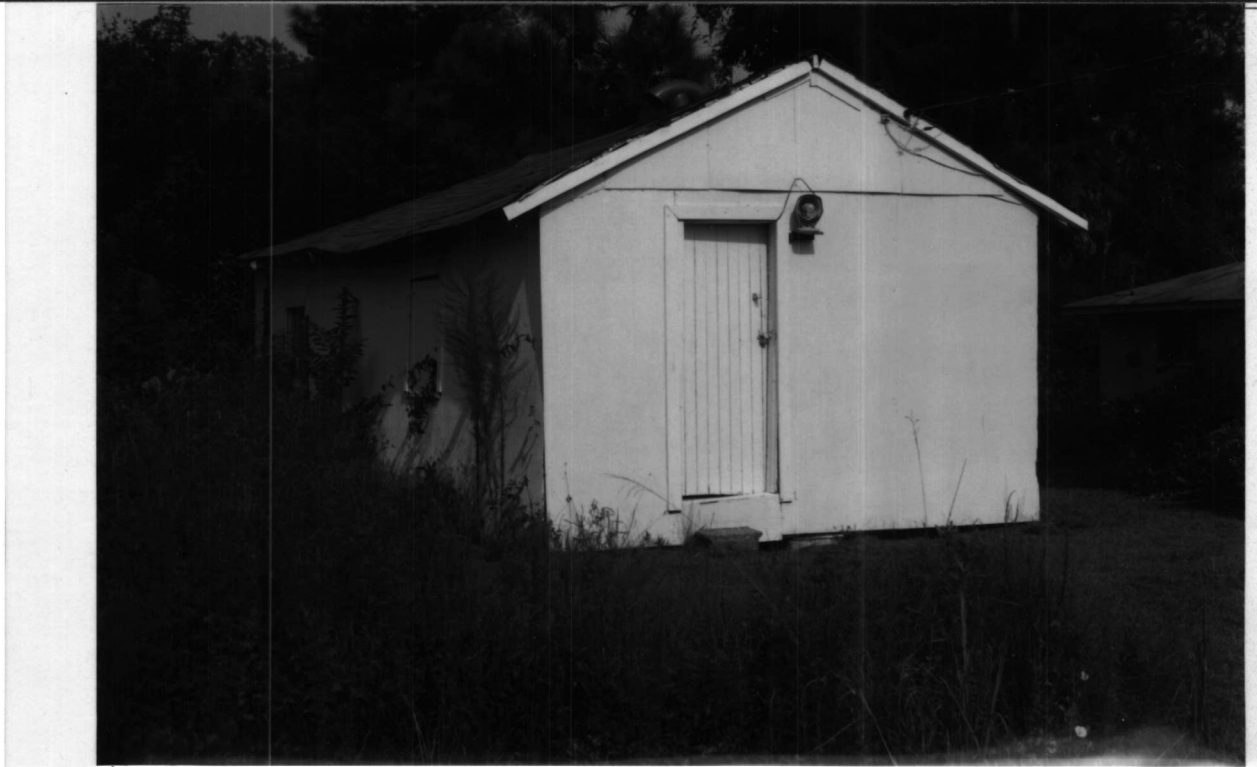
Photograph:

Roll # Neg. View of:
H-19 8 ne oblique

Alterations: Alteration date: 1940 ca., 1970 ca. Integrity: fair Condition: fair
Rear section has been added; new front door.

Description: Small rectangular building, c. 15X20. Off-center front door, two windows on each long side.
