**BEAUFORT COUNTY
HISTORIC SITES SURVEY - 1997**

INTENSIVE LEVEL BUILDING INVENTORY FORM

Historic name(s): McLeod General Store Map Ref.: _____ Tax Number: R100 012 000 010B 0000
Common name(s): _____ City Block Ref.: _____ Island: _____
Address/location: Seabrook Drive at railroad tracks City/Vicinity of (vic.) Seabrook
Date: 1875 ca. Alteration date: _____
Ownership: 1. private 2. city 3. county 4. state 5. federal 6. unknown
Category: 1. building 2. site 3. structure 4. object
Historic use(s): commercial Current uses: abandoned

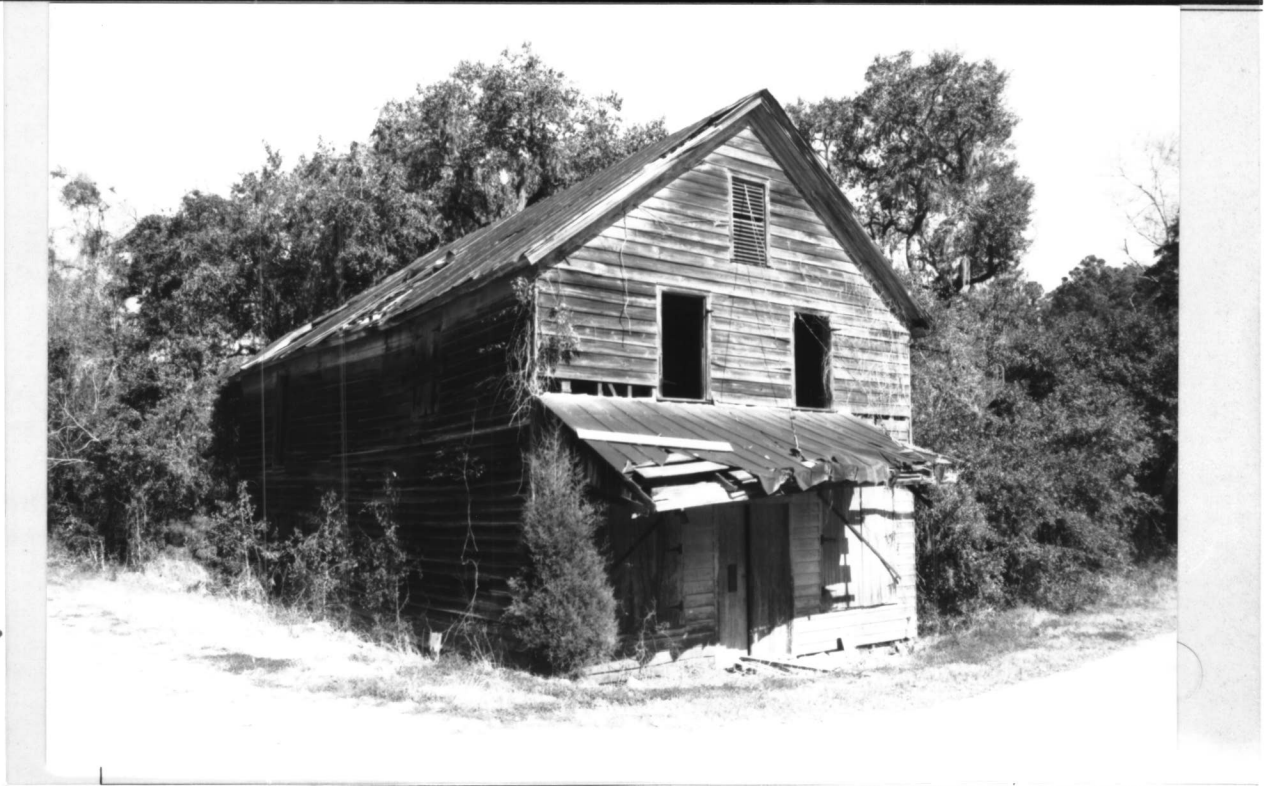
Photograph:

Roll # Neg. View of:
H-4 8 sw oblique

Alterations: Alteration date: _____ Integrity: good Condition: deteriorated

Description: Now deteriorating, a large 2-story store. Central door between 2 display windows, covered by a projecting shed porch.
