**BEAUFORT COUNTY
HISTORIC SITES SURVEY - 1997**

INTENSIVE LEVEL BUILDING INVENTORY FORM

Historic name(s): Supervisor's Home and Office Map Ref.: _____ Tax Number: R100 012 000 0010 0000

Address/location: Seabrook Drive at railroad tracks City/Vicinity of (vic.) Seabrook

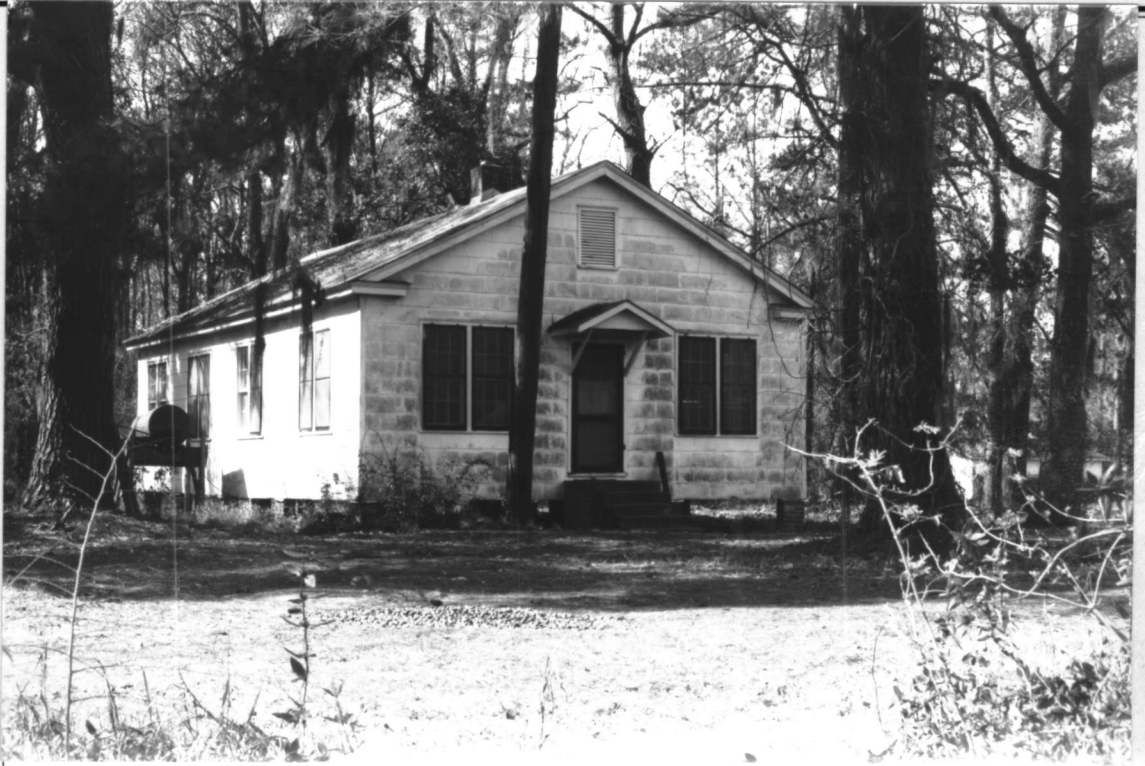
Photograph:

Roll #	Neg.	View of:
<u>H-4</u>	<u>19</u>	<u>se oblique</u>

Style: Folk: gable front Commercial Form: _____

Core Shape: rectangular Stories: 1 story Construction: frame

Roof: Shape: gable (end to front) Material: composition shingle

Chimney: Type: central Material: brick

Windows: double Type: double hung Pane 6/6
Config.: _____

Doors: single Foundation: brick piers

Alterations: Alteration date: _____ Integrity: good Condition: good

Description: Front gable with 3 bays, 3 rooms deep.
