**BEAUFORT COUNTY
HISTORIC SITES SURVEY - 1997**

INTENSIVE LEVEL BUILDING INVENTORY FORM

Historic name(s): Hunting Island Lighthouse Complex Map Ref.: _____ Tax Number: R300 011 000 0010 0000
Common name(s): Oil storage house City Block Ref.: _____ Island: St. Helena Is.
Address/location: Hunting Island State Park City/Vicinity of (vic.) St. Helena Island vic.
Date: 1889 ca. Alteration date: _____
Ownership: 1. private 2. city 3. county 4. state 5. federal 6. unknown
Category: 1. building 2. site 3. structure 4. object
Historic use(s): storage Current uses: visitor center

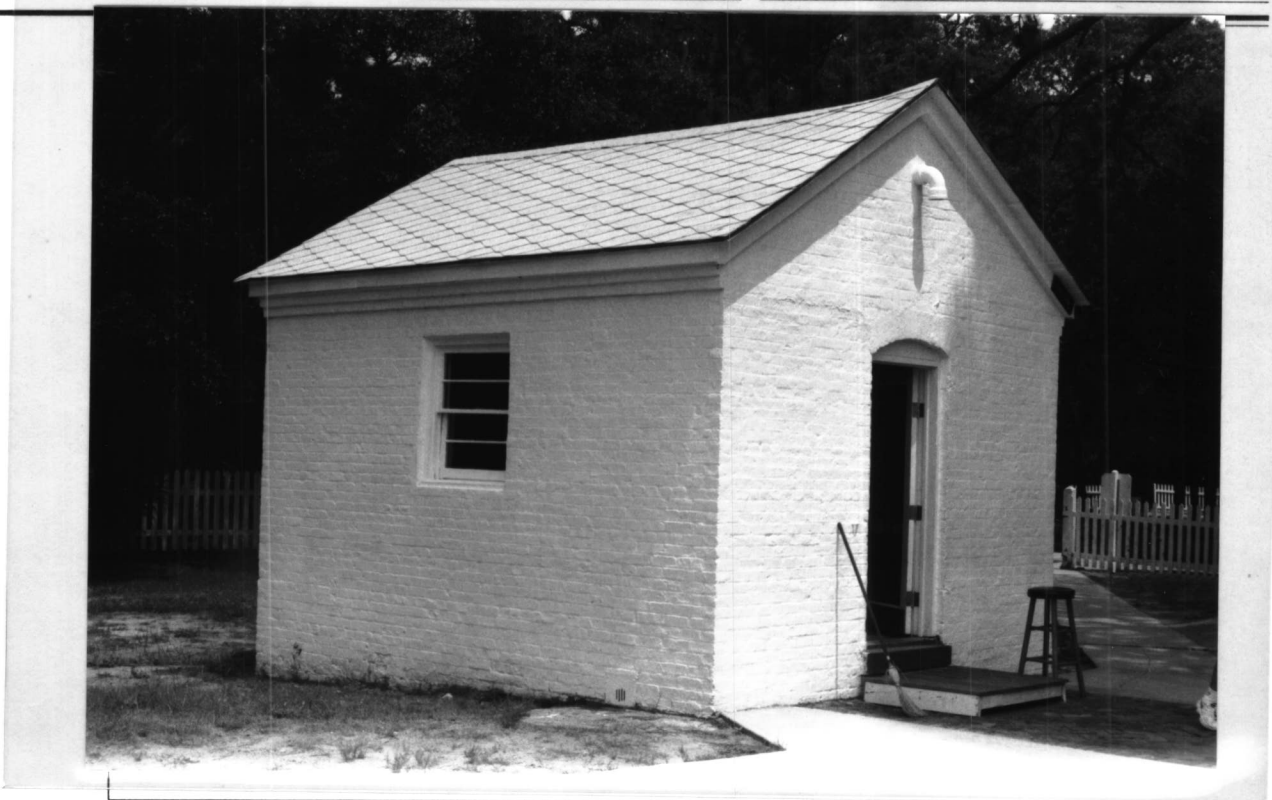
Photograph:

Roll # Neg. View of:
H-18 11 se oblique

Description: Small (ca. 10 x 12) brick building with a one room interior. Central door on front; one single modern window on each side wall.
