**BEAUFORT COUNTY
HISTORIC SITES SURVEY - 1997**

INTENSIVE LEVEL BUILDING INVENTORY FORM

Historic name(s): Hunting Island Lighthouse Complex Map Ref.: _____ Tax Number: R300 011 000 0010 0000
Common name(s): _____ City Block Ref.: _____ Island: St. Helena Is.
Address/location: Hunting Island State Park City/Vicinity of (vic.) St. Helena Island vic.
Date: 1889 ca. Alteration date: _____
Ownership: 1. private 2. city 3. county 4. state 5. federal 6. unknown
Category: 1. building 2. site 3. structure 4. object
Historic use(s): storage Current uses: visitor center

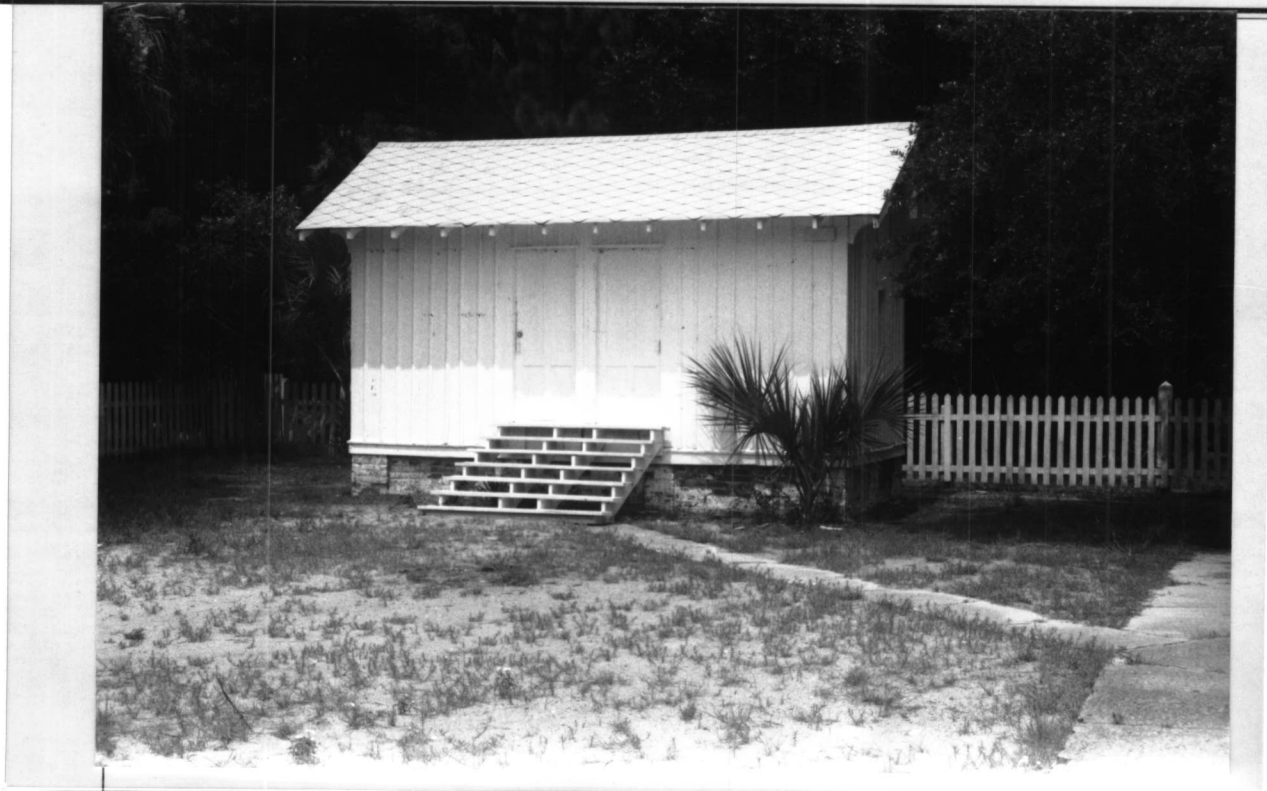
Roll # Neg. View of:
H-18 10 nw oblique

Alterations: Alteration date: _____ Integrity: good Condition: excellent

Description: Small, one or two room building. Paired doors on long side, with new wooden steps leading to main floor. Exposed, shaped rafter tails.
