**BEAUFORT COUNTY
HISTORIC SITES SURVEY - 1997**

INTENSIVE LEVEL BUILDING INVENTORY FORM

Historic name(s): Brays Island Map Ref.: _____ Tax Number: R700.025.000.0001.0000

Common name(s): Sales Office City Block Ref.: _____ Island: _____

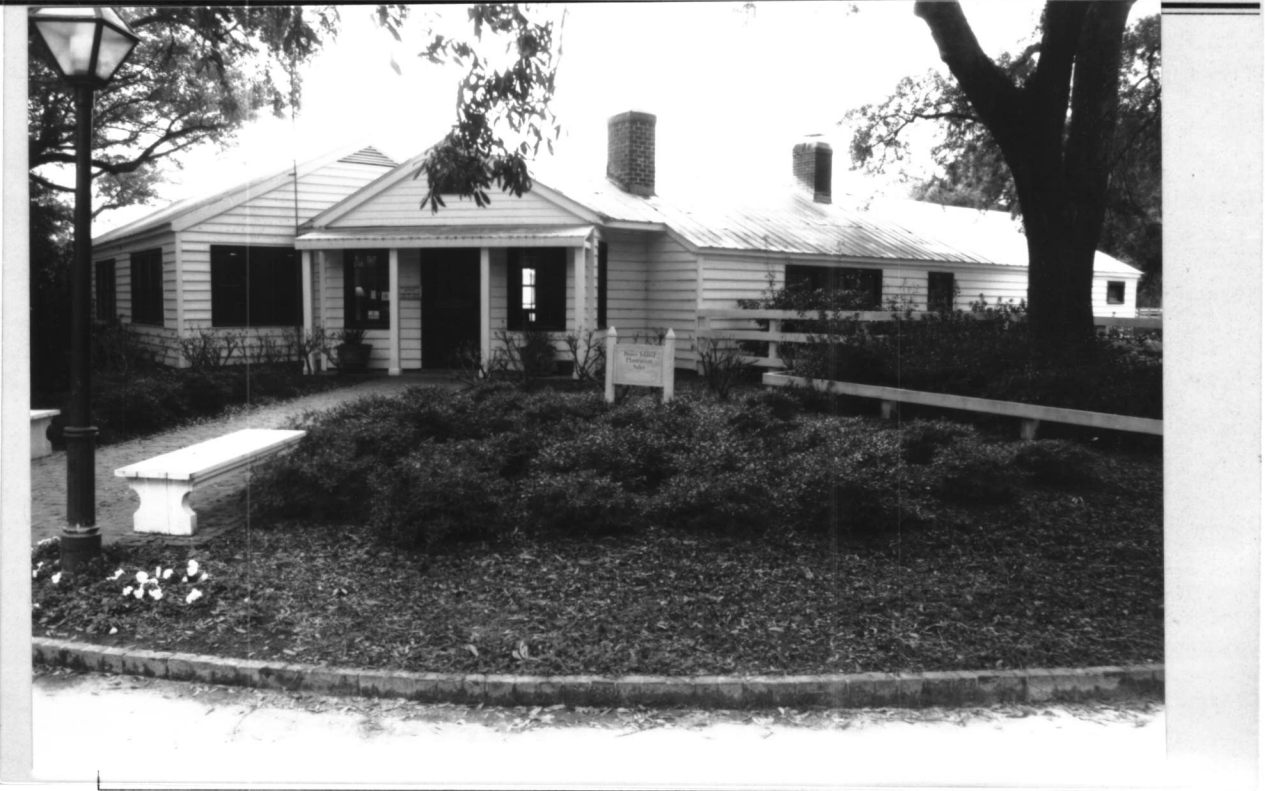
Photograph:

Roll # Neg. View of:
H-5 17 ne oblique

Description: U-shaped building, apparently 2 buildings joined together. Entrance with porch on a canted corner.

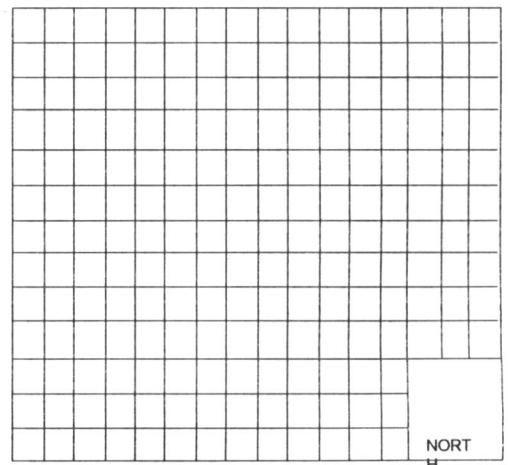
Sketch:

Core Shape: U Stories: 1 story Construction: frame
