**BEAUFORT COUNTY
HISTORIC SITES SURVEY - 1997**

INTENSIVE LEVEL BUILDING INVENTORY FORM

Historic name(s): CCC Mess Hall Map Ref.: _____ Tax Number: R300 011 000 0010 0000
Common name(s): Maintenance City Block Ref.: _____ Island: Hunting Is.
Address/location: 2555 Shed Road City/Vicinity of (vic.) Hunting Island
Date: 1938 ca. Alteration date: _____
Ownership: 1. private 2. city 3. county 4. state 5. federal 6. unknown
Category: 1. building 2. site 3. structure 4. object
Historic use(s): dining hall Current uses: maintenance shed

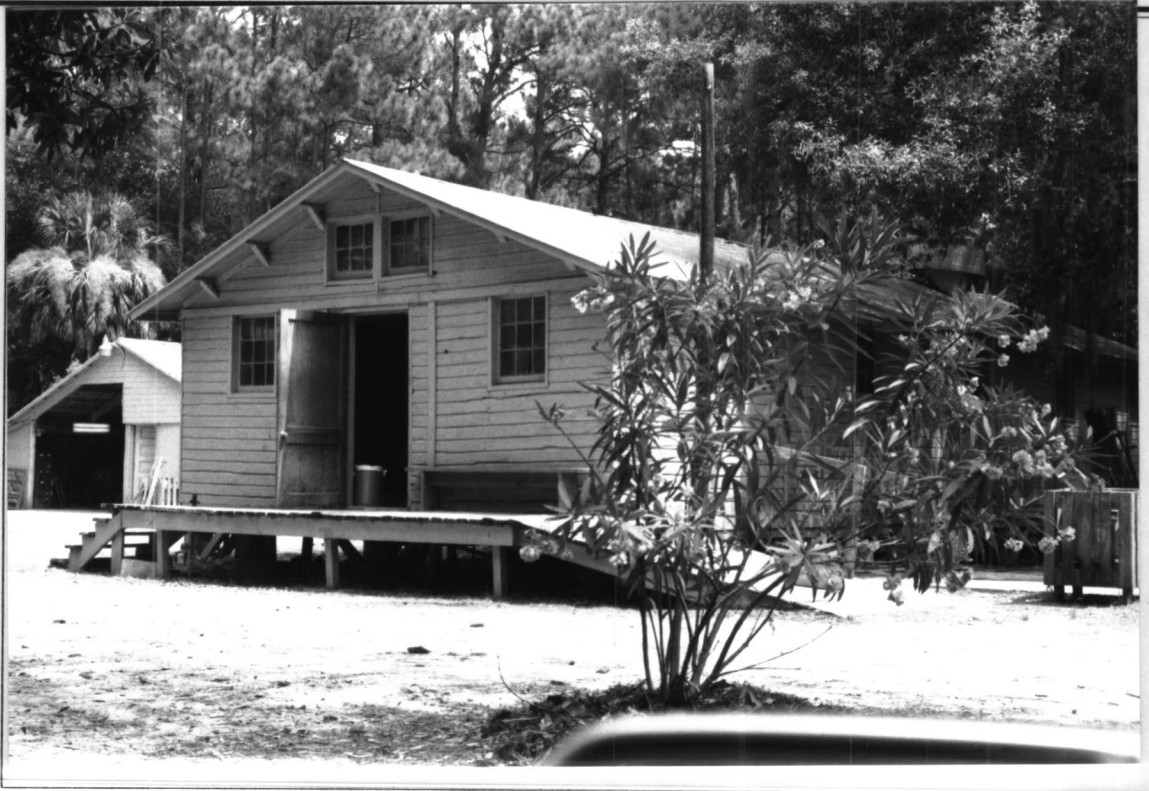
Roll # Neg. View of:
H-18 7 se oblique

Alterations: Alteration date: _____ Integrity: good Condition: good

Description: Simple front gable, 1 bay wide building with a central double door under the gable; single door on left side. Overhanging eaves supported by simple brackets. Unique feature--diagonal brackets extending from ground level of foundation piers upward to bottom plate.
