**BEAUFORT COUNTY
HISTORIC SITES SURVEY - 1997**

INTENSIVE LEVEL BUILDING INVENTORY FORM

Site Number: U- 13 - 354
Access County Site #
USGS Quad: 025 Beaufort
Doc. Level: Intensive Level-Building

Historic name(s): Goings House Map Ref.: _____ Tax Number: R100 028 000 156A 0000
Common name(s): _____ City Block Ref.: _____ Island: _____
Address/location: ^{368A} 300 Parris Island Gateway City/Vicinity of (vic.) Beaufort vic.
Date: 1900 Alteration date: 1981
Ownership: 1. private 2. city 3. county 4. state 5. federal 6. unknown
Category: 1. building 2. site 3. structure 4. object
Historic use(s): single dwelling Current uses: single dwelling

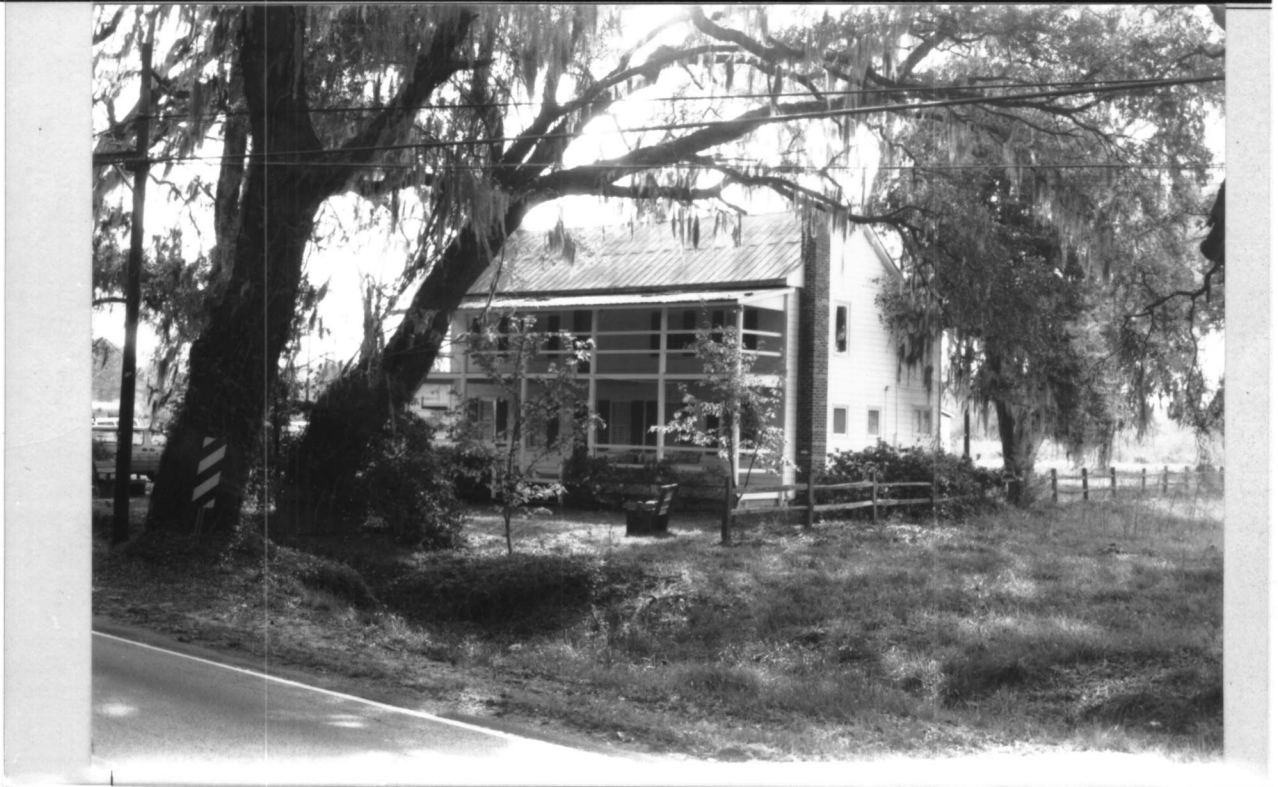
Roll # Neg. View of:
H-8 8 sw oblique

Alterations: Alteration date: 1981 Integrity: fair Condition: good
 Restored 1981; resided with particle board, foundation filled in, side windows removed and replace with square 1-pane windows.

Description: 2-story I house with ell at back. 6 bays, door is third from left. 5 bays on second floor, door in center.
