**BEAUFORT COUNTY
HISTORIC SITES SURVEY - 1997**

INTENSIVE LEVEL BUILDING INVENTORY FORM

Historic name(s): Penn Center Historic District Map Ref.: _____ Tax Number: R300 016 000 0094 0000
Common name(s): Silos City Block Ref.: _____ Island: St. Helena Is.
Address/location: 18 Penn Center Circle City/Vicinity of (vic.) St. Helena Island
Date: 1920 ca. Alteration date: _____
Ownership: 1. private 2. city 3. county 4. state 5. federal 6. unknown
Category: 1. building 2. site 3. structure 4. object
Historic use(s): silos Current uses: abandoned

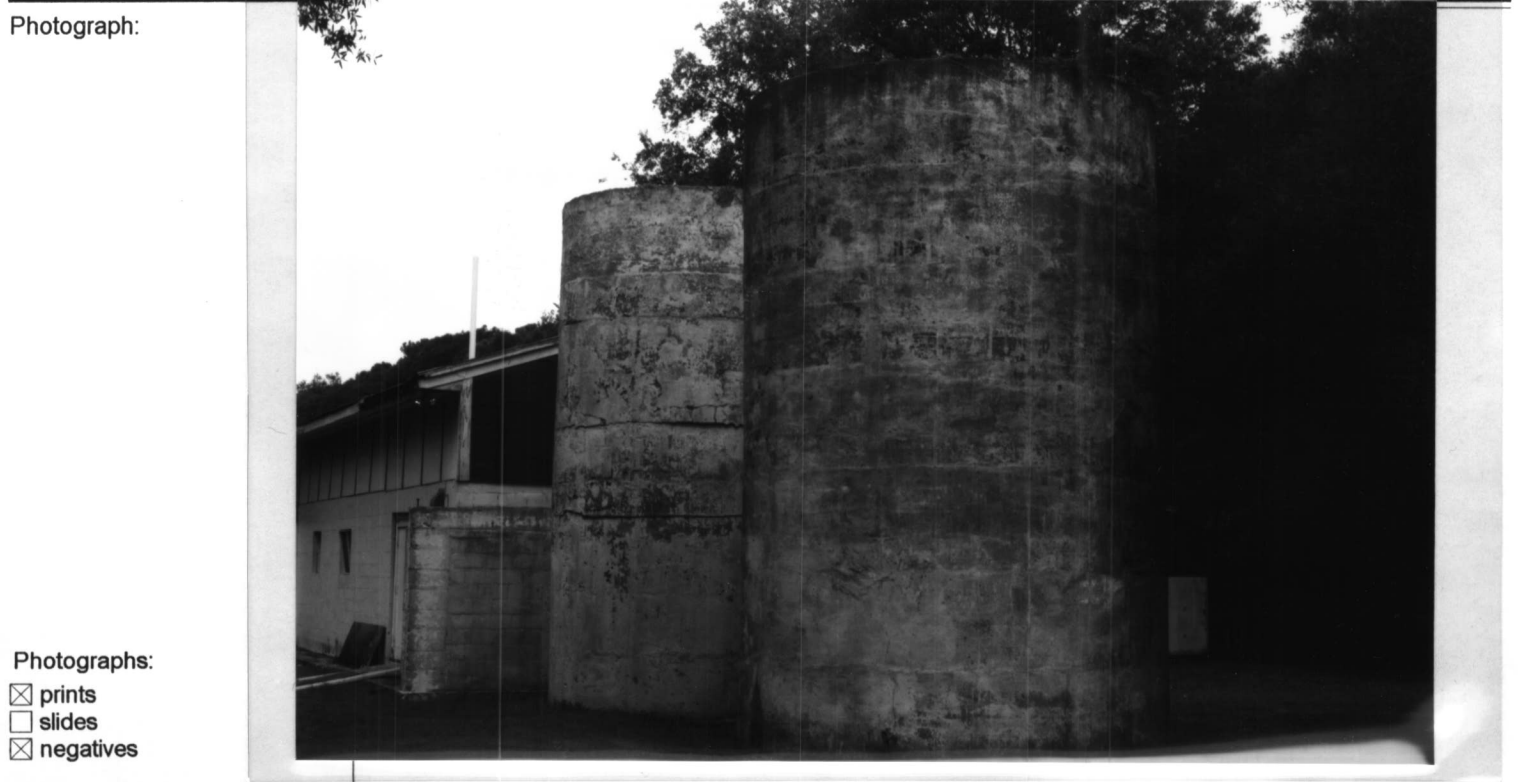
Roll # Neg. View of:
H-16 23A southwest elevation

Alterations: Alteration date: _____ Integrity: good Condition: deteriorated

Description: Two round silos, c. 30 feet tall and 10 feet diameter. Built of combined concrete and tabby material. Openings along one side. Now unused, tops have collapsed.
