**BEAUFORT COUNTY
HISTORIC SITES SURVEY - 1997**

INTENSIVE LEVEL BUILDING INVENTORY FORM

Historic name(s): Israelite Church Map Ref.: _____ Tax Number: R200 010 000 0044 0000
Common name(s): _____ City Block Ref.: _____ Island: Lady's Is.
Address/location: 29 Israelite Church Road City/Vicinity of (vic.): Lady's Island
Date: 1900 Alteration date: 1980?
Ownership: 1. private 2. city 3. county 4. state 5. federal 6. unknown
Category: 1. building 2. site 3. structure 4. object
Historic use(s): Church Current uses: Church

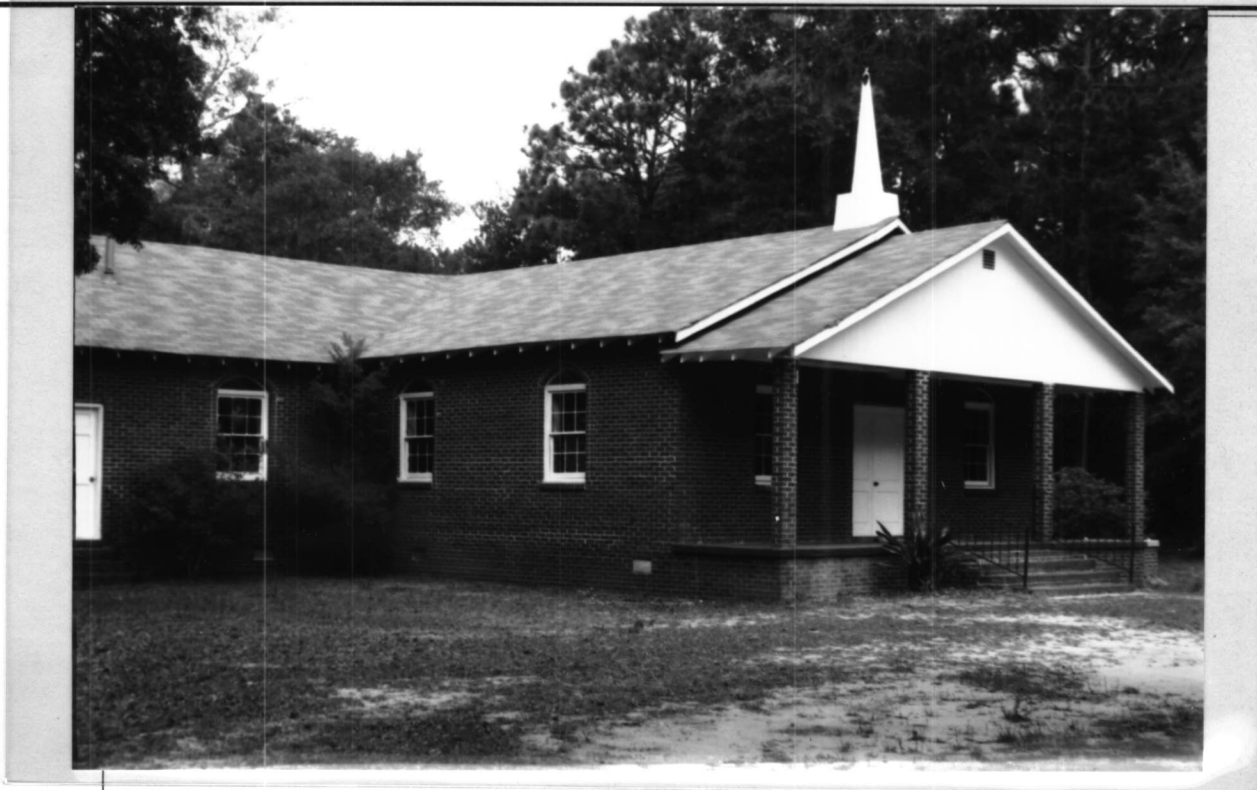
Photograph:

Roll #	Neg.	View of:
<u>H-9</u>	<u>23</u>	<u>se oblique</u>
_____	_____	_____
_____	_____	_____
_____	_____	_____

Alterations: Alteration date: 1980? Integrity: fair Condition: excellent

Brick veneer appears added, one- or two-room addition to left side rear..

Description: Front gabled church with small steeple at center front. Shallow gable roof; porch roof projects below eave line at the same pitch. plain brick piers support porch. Exposed rafter tails. Wing extends to left from rear. Brick porch and steps. Facade features 3 bays with a central door; windows surmounted by arched transoms.
