**BEAUFORT COUNTY
HISTORIC SITES SURVEY - 1997**

INTENSIVE LEVEL BUILDING INVENTORY FORM

Site Number: U- 13 - 409
Access County Site #
USGS Quad: 442 St Helena Sound
Doc. Level: Intensive Level-Building

Historic name(s): _____ Map Ref.: _____ Tax Number: R300.029.000.0023.0000
Common name(s): _____ City Block Ref.: _____ Island: St. Helena Is.
Address/location: **570 Lands End Road** City/Vicinity of (vic.) St. Helena Island
Date: 1945 ca. Alteration date: _____
Ownership: 1. private 2. city 3. county 4. state 5. federal 6. unknown
Category: 1. building 2. site 3. structure 4. object
Historic use(s): commercial Current uses: commercial

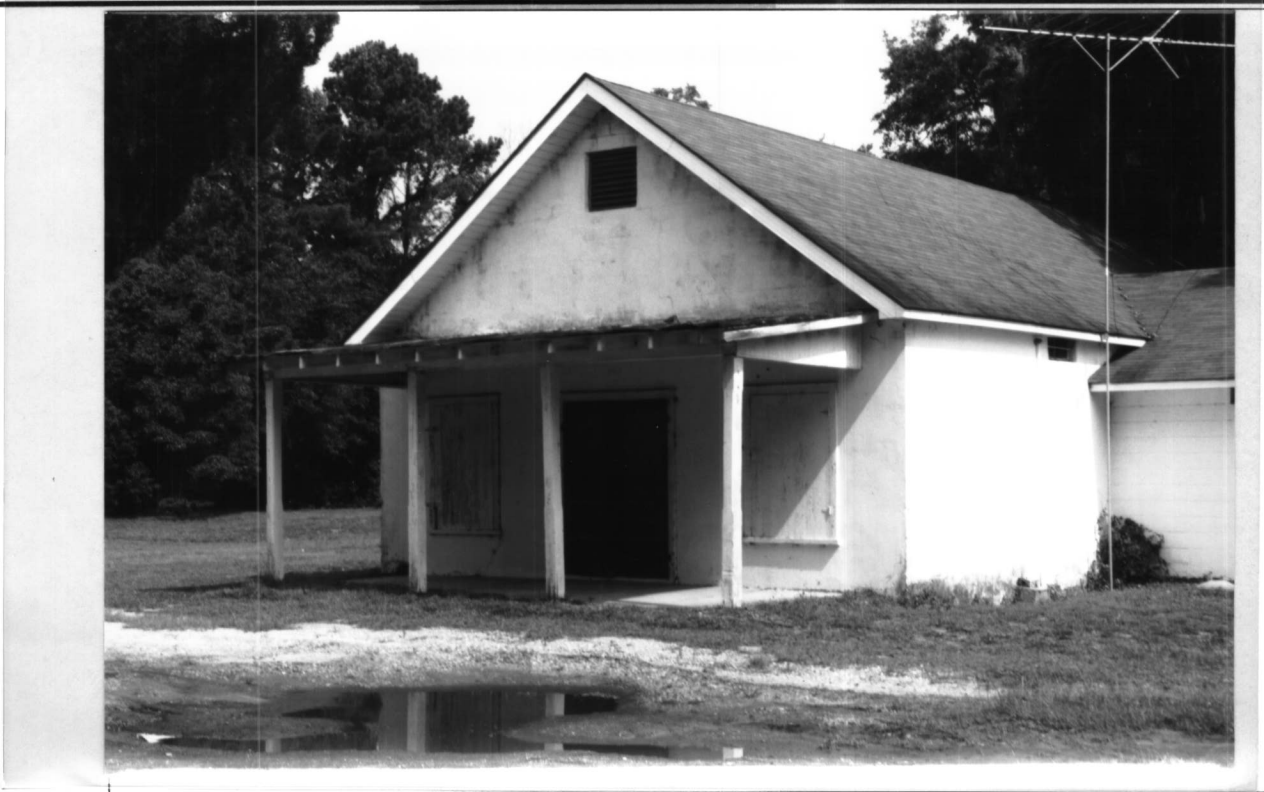
Photograph:

Roll # Neg. View of:
H-15 6 ne oblique

Alterations: Alteration date: _____ Integrity: fair _____ Condition: good _____
 Roof appears new. Cement block addition, 1-room on right side rear

Description: Small front gable store with steeply pitched roof. Three bay facade, central double doors with flanking small display windows, with hinged wooden shutters. Hopper windows at eave lines.
