**BEAUFORT COUNTY
HISTORIC SITES SURVEY - 1997**

INTENSIVE LEVEL BUILDING INVENTORY FORM

Site Number: U- 13 - 410
Access County Site #
USGS Quad: 025 Beaufort
Doc. Level: Intensive Level-Building

Historic name(s): Broomfield United Methodist Church Map Ref.: _____ Tax Number: R200.005.000.0015.0000
Common name(s): _____ City Block Ref.: _____ Island: Lady's Is.
Address/location: 19 Devaux Road City/Vicinity of (vic.) Lady's Island
Date: 1900 Alteration date: 1970 ca.
Ownership: 1. private 2. city 3. county 4. state 5. federal 6. unknown
Category: 1. building 2. site 3. structure 4. object
Historic use(s): Church Current uses: Church

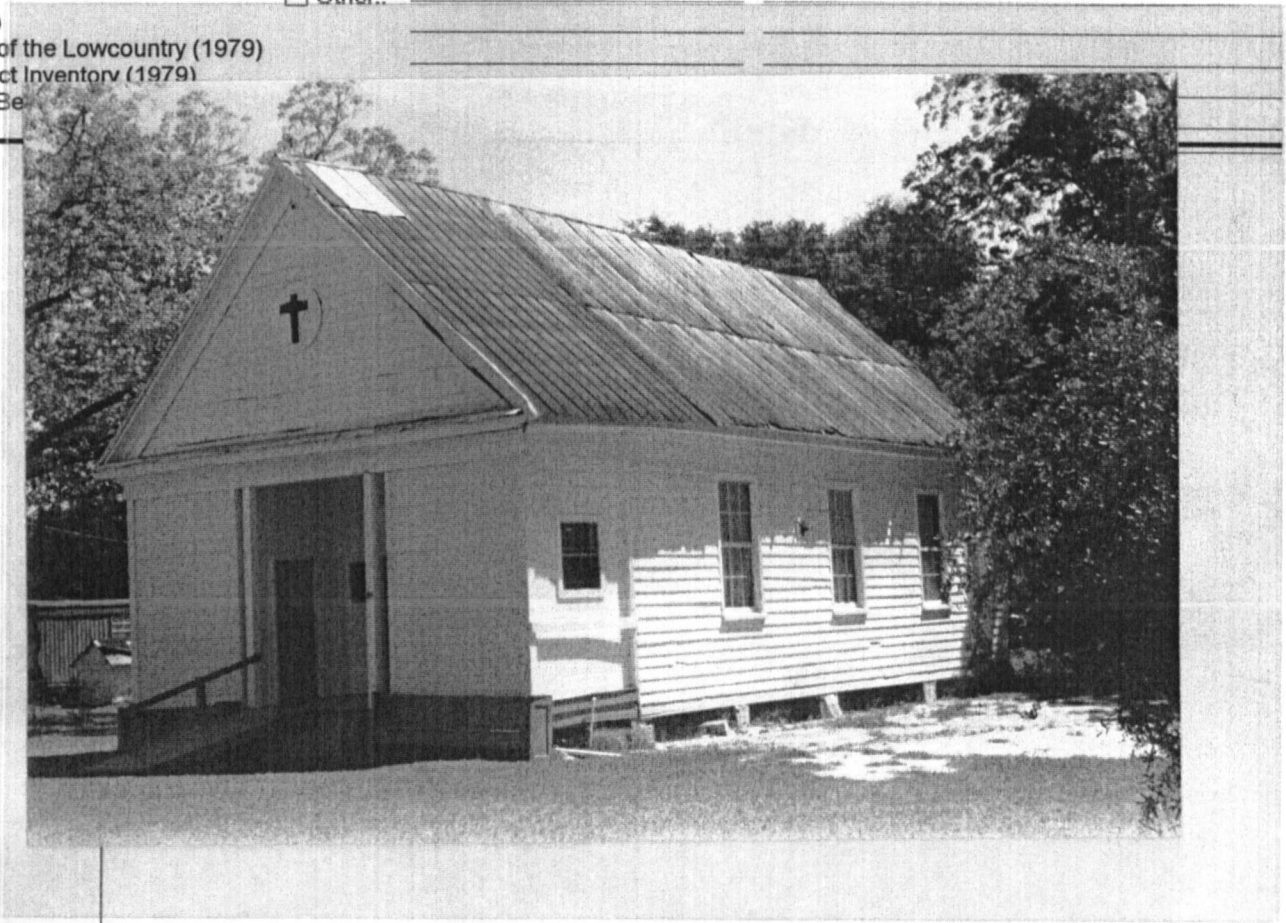
Roll #	Neg.	View of:
<u>H-10</u>	<u>10</u>	<u>sw oblique</u>

Alterations: Alteration date: 1970 ca. Integrity: fair Condition: good
 Two front corners of temple front enclosed to form bathrooms; otherwise good integrity.

Description: Small temple front church without a steeple; central door. 3 window bays along side. Rear door on right side. 2 window bays on rear.
