**BEAUFORT COUNTY
HISTORIC SITES SURVEY - 1997**

INTENSIVE LEVEL BUILDING INVENTORY FORM

Historic name(s): Knights of the Wise Men Lodge Hall Map Ref.: _____ Tax Number: R300 016 0058 0000
Common name(s): _____ City Block Ref.: _____ Island: St. Helena Is.
Address/location: 14 M.L. King Jr. Blvd. City/Vicinity of (vic.) Frogmore
Date: 1930 ca. Alteration date: _____
Ownership: 1. private 2. city 3. county 4. state 5. federal 6. unknown
Category: 1. building 2. site 3. structure 4. object
Historic use(s): fraternal/patriotic/political organization Current uses: abandoned

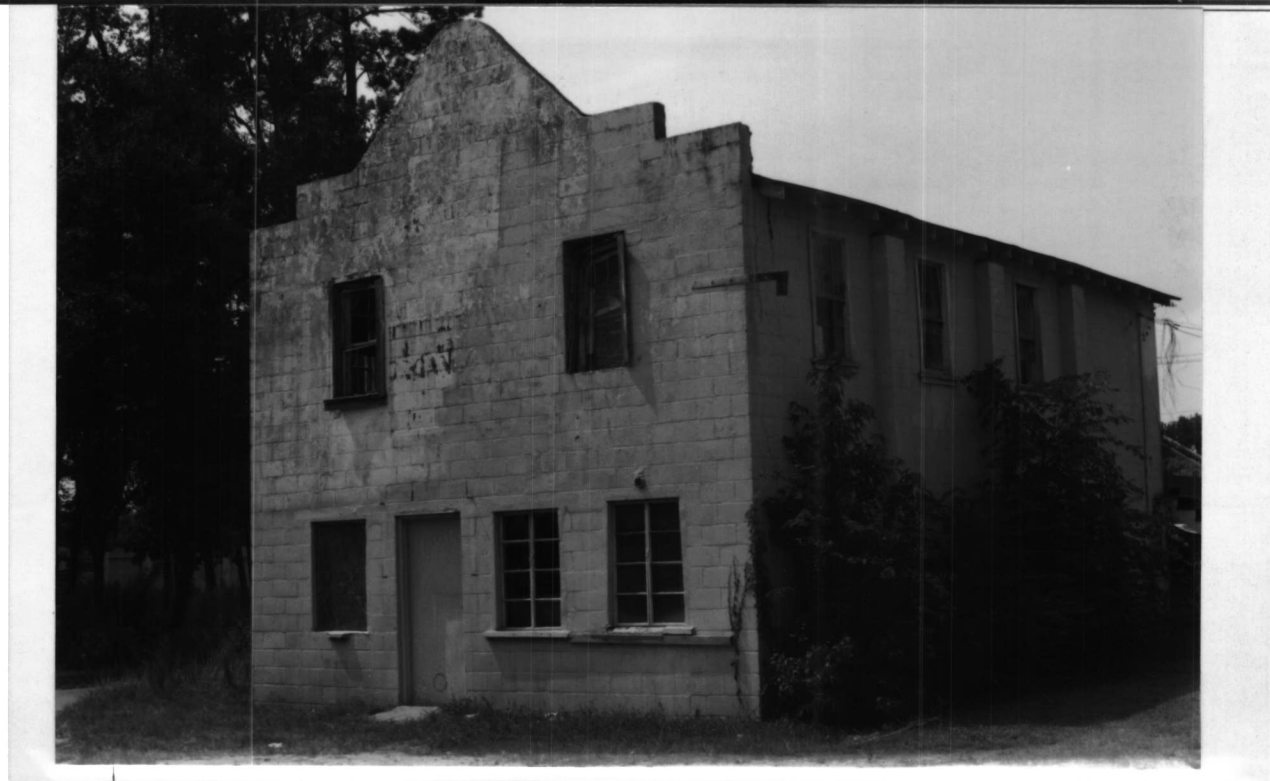
Photograph:

Roll # Neg. View of:
H-19 11 ne oblique

Alterations: Alteration date: _____ Integrity: good Condition: good

Description: Two story cement block building, four bay facade ABAA (A=casement window, B=single door) on first floor, two windows on second floor. Long sides divided into four bays, divided by exterior attached concrete block buttresses. Sham stepped gable above actual front gable.
