**BEAUFORT COUNTY
HISTORIC SITES SURVEY - 1997**

INTENSIVE LEVEL BUILDING INVENTORY FORM

Site Number: U- 13 - 480
Access County Site #
USGS Quad: 442 St Helena Sound
Doc. Level: Intensive Level-Building

Historic name(s): Coffin Point Praise House Map Ref.: _____ Tax Number: R300 012 000 0055
Common name(s): _____ City Block Ref.: _____ Island: St. Helena Is.
Address/location: 61 Coffin Point Road City/Vicinity of (vic.) St. Helena Island
Date: 1900 ca. Alteration date: 1990 ca.
Ownership: 1. private 2. city 3. county 4. state 5. federal 6. unknown
Category: 1. building 2. site 3. structure 4. object
Historic use(s): Praise House Current uses: religious

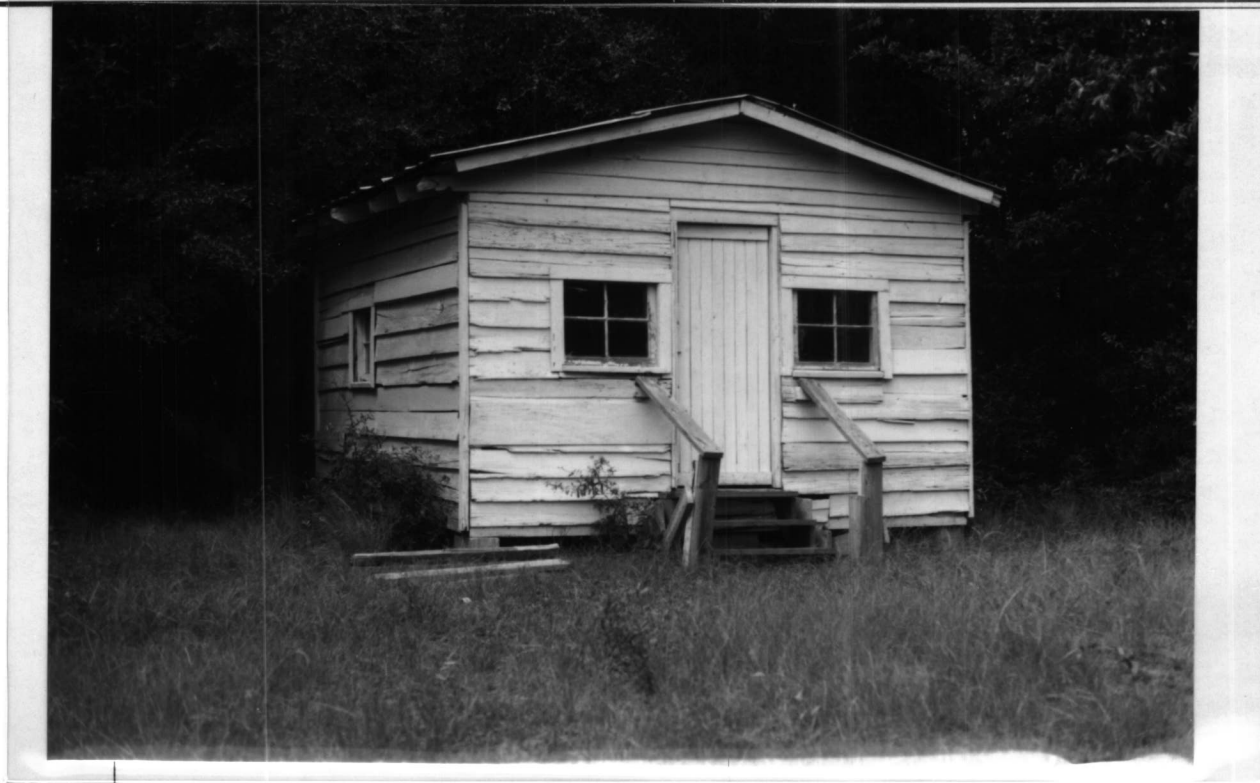
Photograph:

Style: Folk: gable front _____ Commercial Form: _____
 Core Shape: rectangular _____ Stories: 1 story _____ Construction: frame _____
 Roof: Shape: gable (end to front) _____ Material: raised seam metal _____
 Chimney: Type: _____ Material: _____
 Exterior Walls: mix of weatherboard and hewn siding _____
 Windows: single _____ Type: fixed _____ Pane 4-pane fixed _____
 Config.: _____
 Doors: single _____ Foundation: concrete block piers _____
 Porch Height: _____ Porch Width: _____ Porch Roof Shape: _____
 Porch Details: _____ Decorative Elements: _____
 Outbuildings: none _____ Interior Features: _____
 Number of Related Resources: _____
 Surroundings: rural _____ Acreage: _____ Quadrangle: St Helena Sound _____
 Alterations: Alteration date: 1990 ca. _____ Integrity: good _____ Condition: good _____
 new wooden steps to central front door.

Description: Small (10x12) building with a central vertical panel door and two fixed windows on facade, one fixed window on each long side. Shallow front gable roof, exposed rafter tails.
