**BEAUFORT COUNTY
HISTORIC SITES SURVEY - 1997**

INTENSIVE LEVEL BUILDING INVENTORY FORM

Site Number: U- 13 - 482.04
Access County Site #

Historic name(s): Twickenham Plantation Map Ref.: _____ Tax Number: R800 024 000 0121 0000
Common name(s): Twickenham Plantation City Block Ref.: _____ Island: _____
Address/location: off River Road City/Vicinity of (vic.) Yemassee vic.
Date: 1930 ca. Alteration date: _____
Ownership: 1. private 2. city 3. county 4. state 5. federal 6. unknown
Category: 1. building 2. site 3. structure 4. object
Historic use(s): stables Current uses: stables

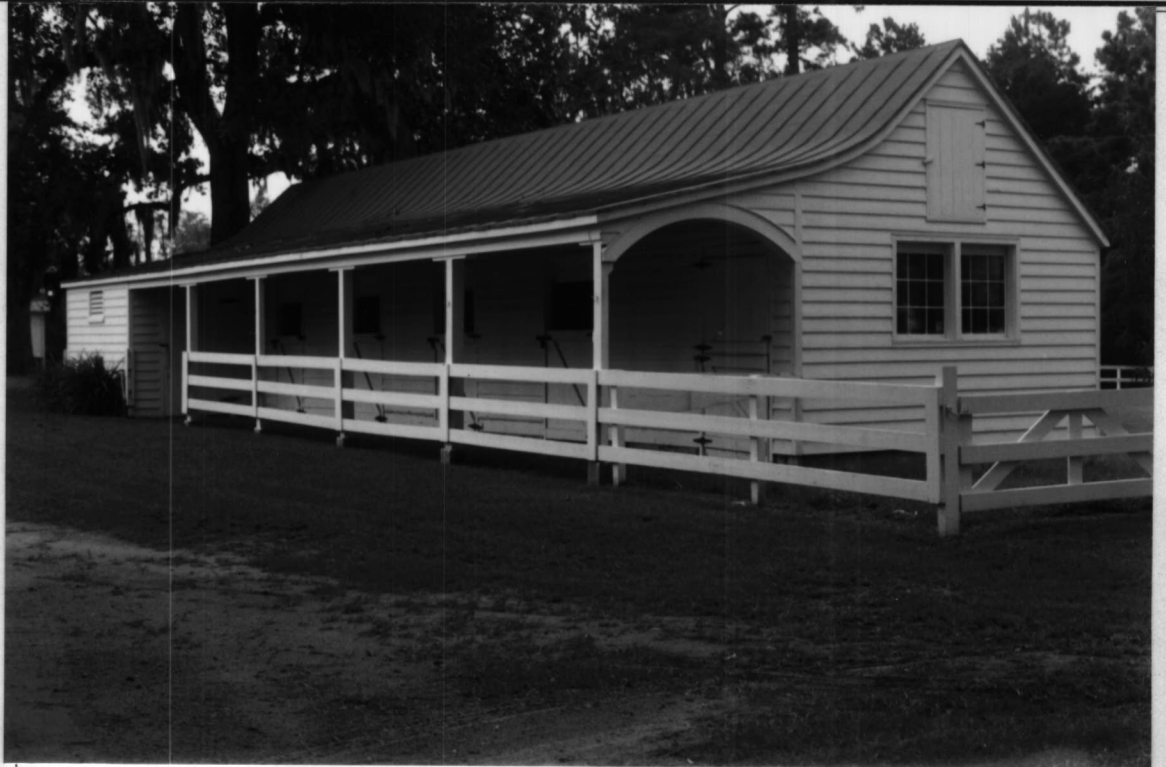
Photograph:

Roll # Neg. View of:
H-21 5 sw oblique

Description: Five-bay side gable stable. Front roof sweeps out to form porch over the stable doors. The left end of the porch has been enclosed to form one room.
