BEAUFORT COUNTY
HISTORIC SITES SURVEY - 1997

RECONNAISSANCE LEVEL INVENTORY FORM

Site Number: U - 13 - 492

Historic name(s): Tabby ruin

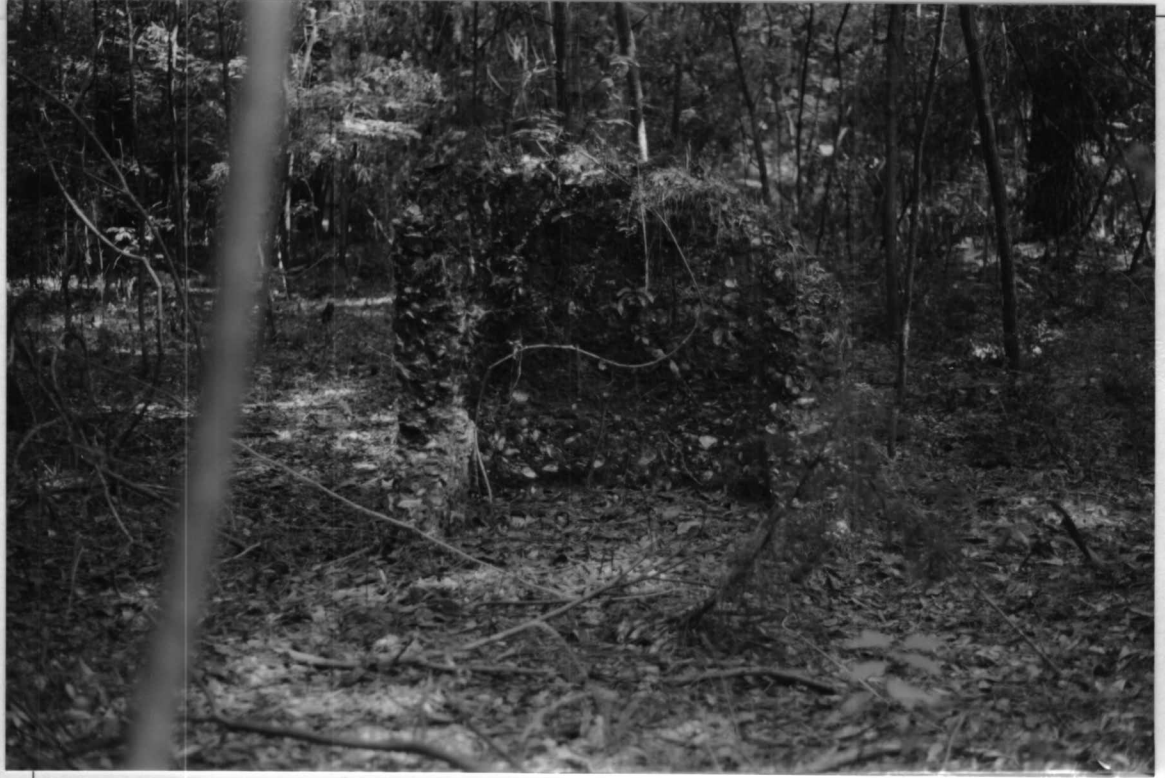
Photograph:

Condition: excellent good fair deteriorated ruin

Notes: Tabby end wall similar to those at Haig Point: 4' high, 4' wide, remnants of side walls; 30' to east is small rubble of red brick.
