**BEAUFORT COUNTY
HISTORIC SITES SURVEY - 1997**

INTENSIVE LEVEL BUILDING INVENTORY FORM

Site Number: U- 13 - 504
Access County Site #
USGS Quad: 025 Beaufort
Doc. Level: Intensive Level-Building

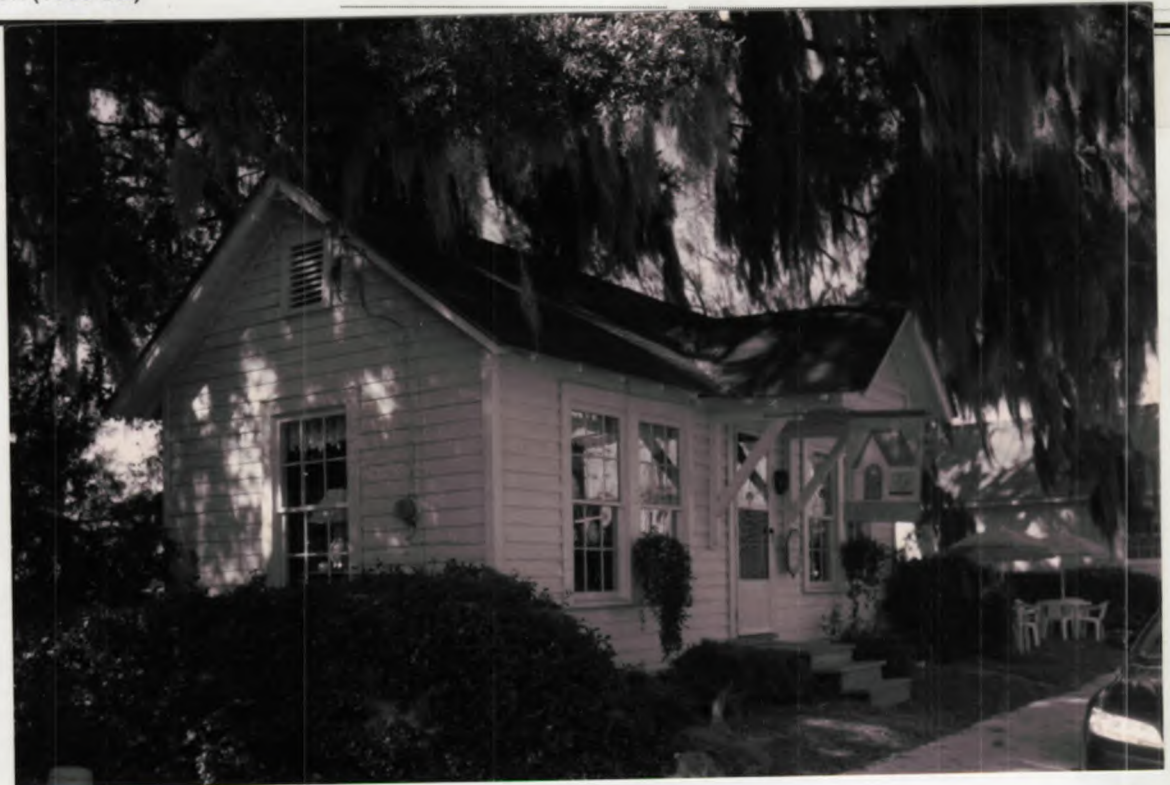
Roll # Neg. View of:
B-23 1 E facade, fac. W

Alterations: Alteration date: _____ Integrity: excellent _____ Condition: good _____
 An aluminum storm door at the entrance represents the only exterior alteration.

Description: Rectangular 3 x 1 bay commercial building w/lateral gable composition shingle roof. Exposed rafter ends at eaves. East facade has central entrance flanked by double 6/6 double hung windows. Entrance has a entrance bay only gable awning supported by triangular wood brackets. Side elevations have single 6/6 windows and small rectangular louvered attic vents within their gables. Rear elevation has no openings and an exterior brick flue.
