**BEAUFORT COUNTY
HISTORIC SITES SURVEY - 1997**

INTENSIVE LEVEL BUILDING INVENTORY FORM

Site Number: U- 13 - 506
Access County Site #
 USGS Quad: 025 Beaufort
 Doc. Level: Intensive Level-Building

Historic name(s): _____ Map Ref.: PR 12 Tax Number: R110 011 000 0072 0000
 Common name(s): _____ City Block Ref.: _____ Island: Port Royal Is.
 Address/location: 910 7th St. City/Vicinity of (vic.) Port Royal
 Date: 1922 Alteration date: 1980 ca.
 Ownership: 1. private 2. city 3. county 4. state 5. federal 6. unknown
 Category: 1. building 2. site 3. structure 4. object
 Historic use(s): single dwelling Current uses: single dwelling

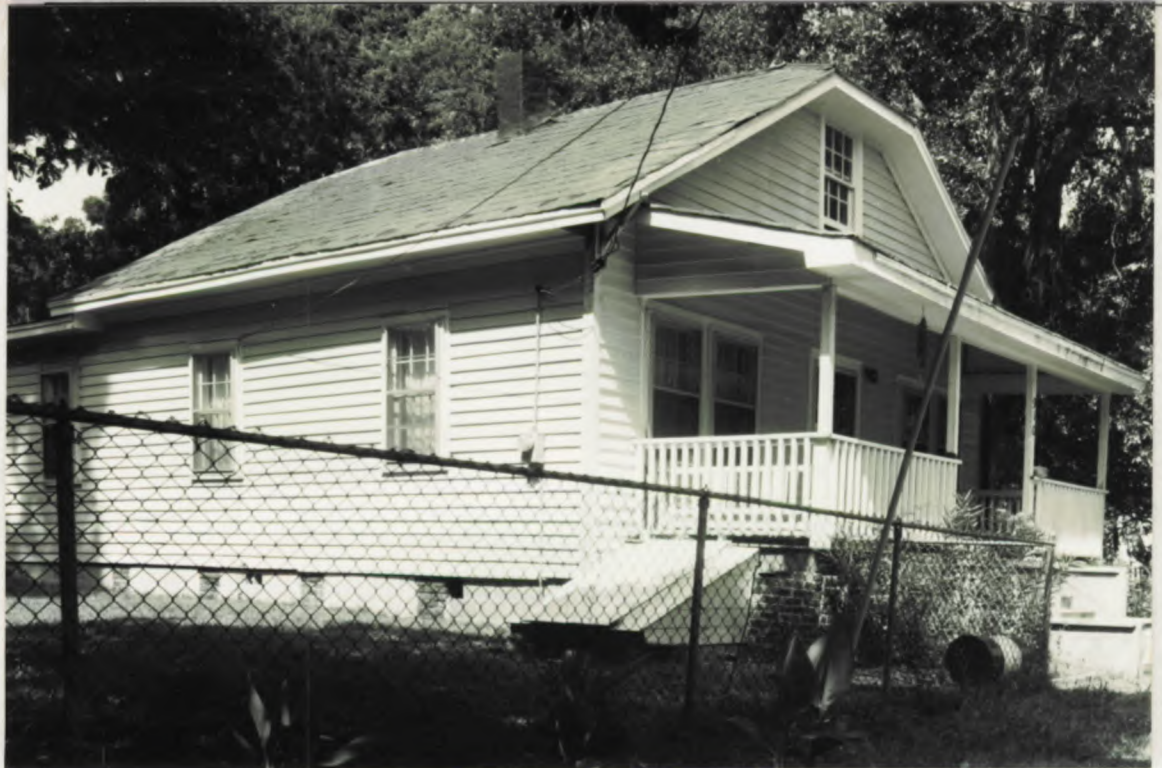
Roll # Neg. View of:
 B-08 11 S facade & w elev., fac. NE

Alterations: Alteration date: 1980 ca. Integrity: good Condition: good
 Storm windows, replacement porch, stuccoed masonry foundation infill.

Description: Rectangular 1.5 story 3 x 3 bay frame dwelling w/front-facing jerkin head roof; 2 1 bay deep frame additions at rear. Patterned metal shingle roof. Central entrance at facade flanked by double 6/6 double hung sash windows. Single 6/6 windows at gable end and at side elevs.
