**BEAUFORT COUNTY
HISTORIC SITES SURVEY - 1997**

INTENSIVE LEVEL BUILDING INVENTORY FORM

Site Number: U- 13 - 524
Access County Site #
USGS Quad: 025 Beaufort
Doc. Level: Intensive Level-Building

Historic name(s): _____ Map Ref.: PR 12 Tax Number: R110 011 000 0046 0000
Common name(s): _____ City Block Ref.: _____ Island: Port Royal Is.
Address/location: 903 London Ave. City/Vicinity of (vic.): Port Royal
Date: 1920 ca. Alteration date: 1980 ca.
Ownership: 1. private 2. city 3. county 4. state 5. federal 6. unknown
Category: 1. building 2. site 3. structure 4. object
Historic use(s): single dwelling Current uses: single dwelling

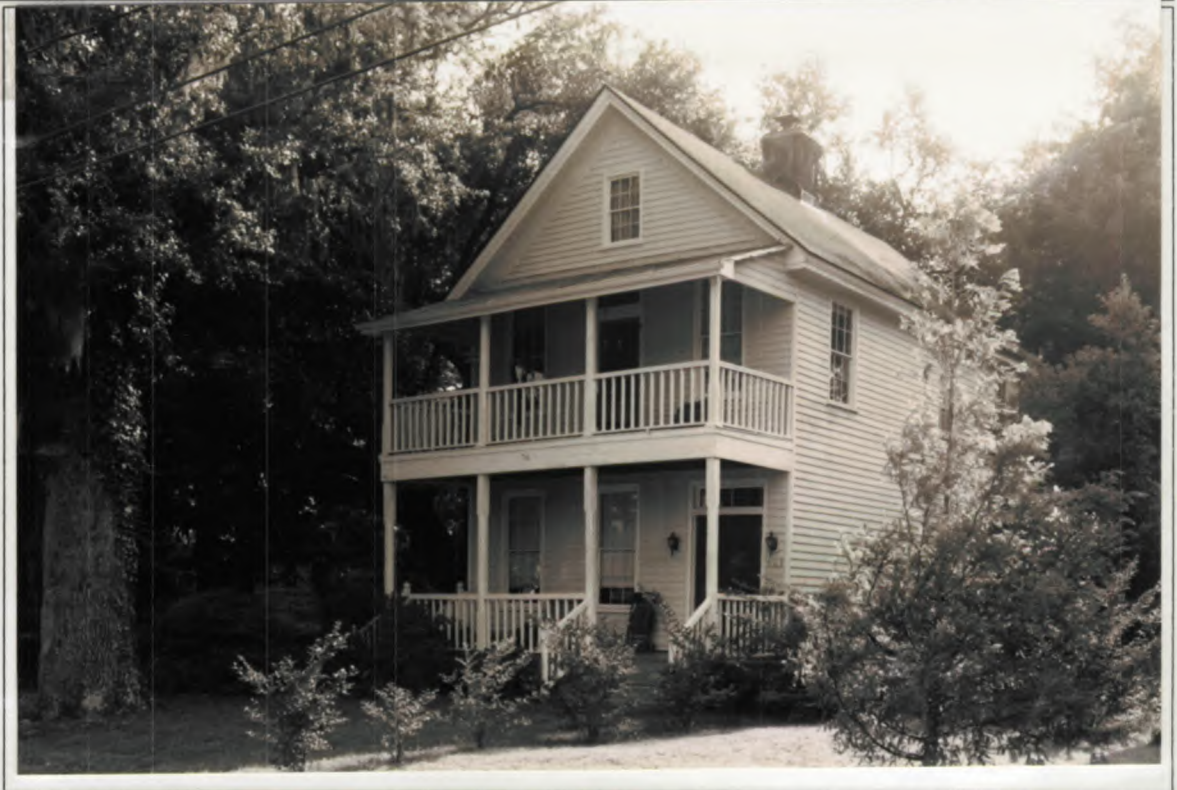
Photograph:

Roll # Neg. View of:
B-08 29 E facade & N elev., fac. SW

Alterations: Alteration date: 1980 ca. Integrity: good Condition: good
 Porch railings, addition.

Description: Rectangular 2 story frame 3 x 2 bay dwelling w/front-facing gable roof; rear 3 x 2 bay addition. Two story porch with shed roof retains chamfered posts and has recent slat balustrade. Principal entrance at N bay of facade has transom. Two southern bays have 6/6 double hung sash windows. Similar fenestration at 2nd level except that door has no transom. 6/6 windows at side elevs.
