**BEAUFORT COUNTY
HISTORIC SITES SURVEY - 1997**

INTENSIVE LEVEL BUILDING INVENTORY FORM

Site Number: U- 13 - 532
Access County Site #
USGS Quad: 025 Beaufort
Doc. Level: Intensive Level-Building

Historic name(s): _____ Map Ref.: PR 12 Tax Number: R110 011 000 0035 0000
Common name(s): _____ City Block Ref.: _____ Island: Port Royal Is.
Address/location: 911 11th St. City/Vicinity of (vic.): Port Royal
Date: 1920 ca. Alteration date: 1970 ca.
Ownership: 1. private 2. city 3. county 4. state 5. federal 6. unknown
Category: 1. building 2. site 3. structure 4. object
Historic use(s): single dwelling Current uses: single dwelling

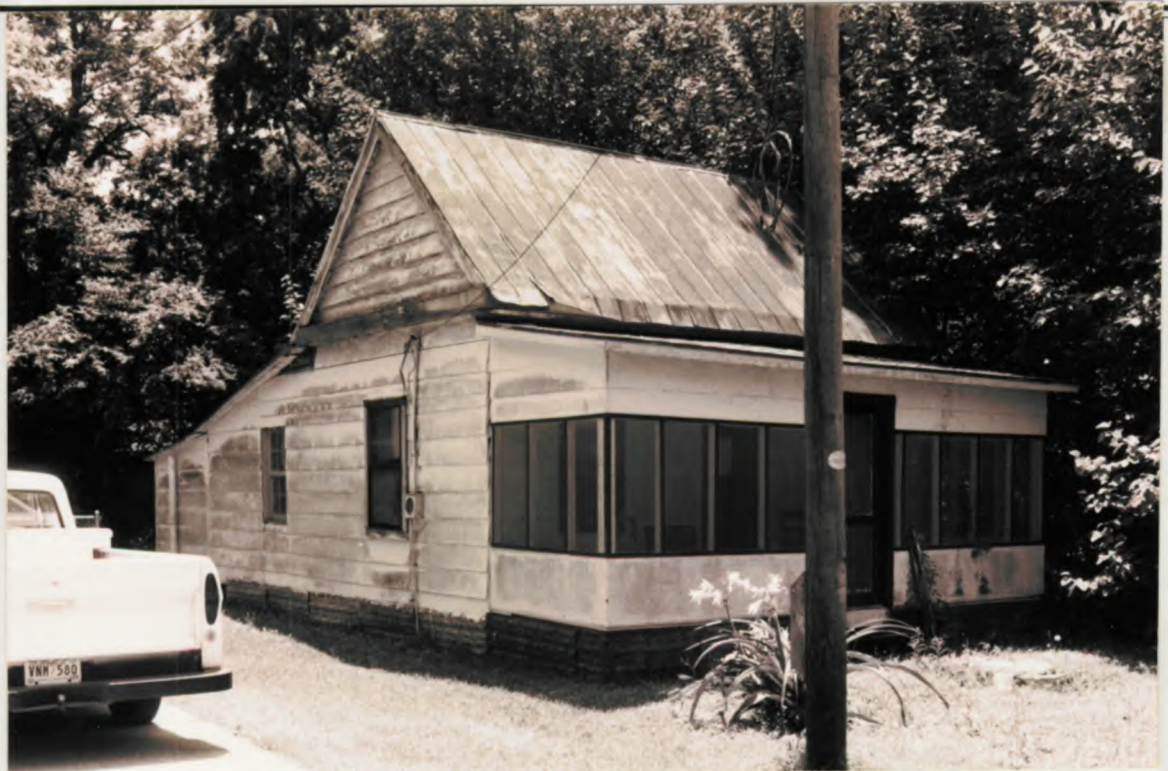
Roll # Neg. View of:
B-09 2 N & E elevs., fac. SW

Style: Folk: hall-and-parlor Commercial Form: _____
 Core Shape: rectangular Stories: 1 story Construction: frame
 Roof: Shape: gable (lateral) Material: V crimp metal
 Chimney: Type: not visible Material: _____
 Exterior Walls: weatherboard
 Windows: single Type: double hung Pane 6/6
 Config.: replacement synthetic
 Doors: single Foundation: brick piers
 Porch Height: 1 story Porch Width: full facade Porch Roof Shape: shed
 Porch Details: apron wall Insect screening Decorative Elements: _____
 Outbuildings: Interior Features: _____
 Number of Related Resources: _____
 Surroundings: residential Acreage: _____ Quadrangle: Beaufort
 Alterations: Alteration date: 1970 ca. Integrity: fair Condition: good
 porch screening, apron wall and roof framing

Description: Rectangular 1 story 3 x 1 bay frame dwelling w/rear shed addition; pedimented gable ends
