**BEAUFORT COUNTY
HISTORIC SITES SURVEY - 1997**

INTENSIVE LEVEL BUILDING INVENTORY FORM

Site Number: U- 13 - 533
Access County Site #
USGS Quad: 025 Beaufort
Doc. Level: Intensive Level-Building

Historic name(s): _____ Map Ref.: PR 12 Tax Number: R110 011 000 0032 0000
Common name(s): _____ City Block Ref.: _____ Island: Port Royal Is.
Address/location: 909 11th St. City/Vicinity of (vic.): Port Royal
Date: 1920 Alteration date: _____
Ownership: 1. private 2. city 3. county 4. state 5. federal 6. unknown
Category: 1. building 2. site 3. structure 4. object
Historic use(s): single dwelling Current uses: single dwelling

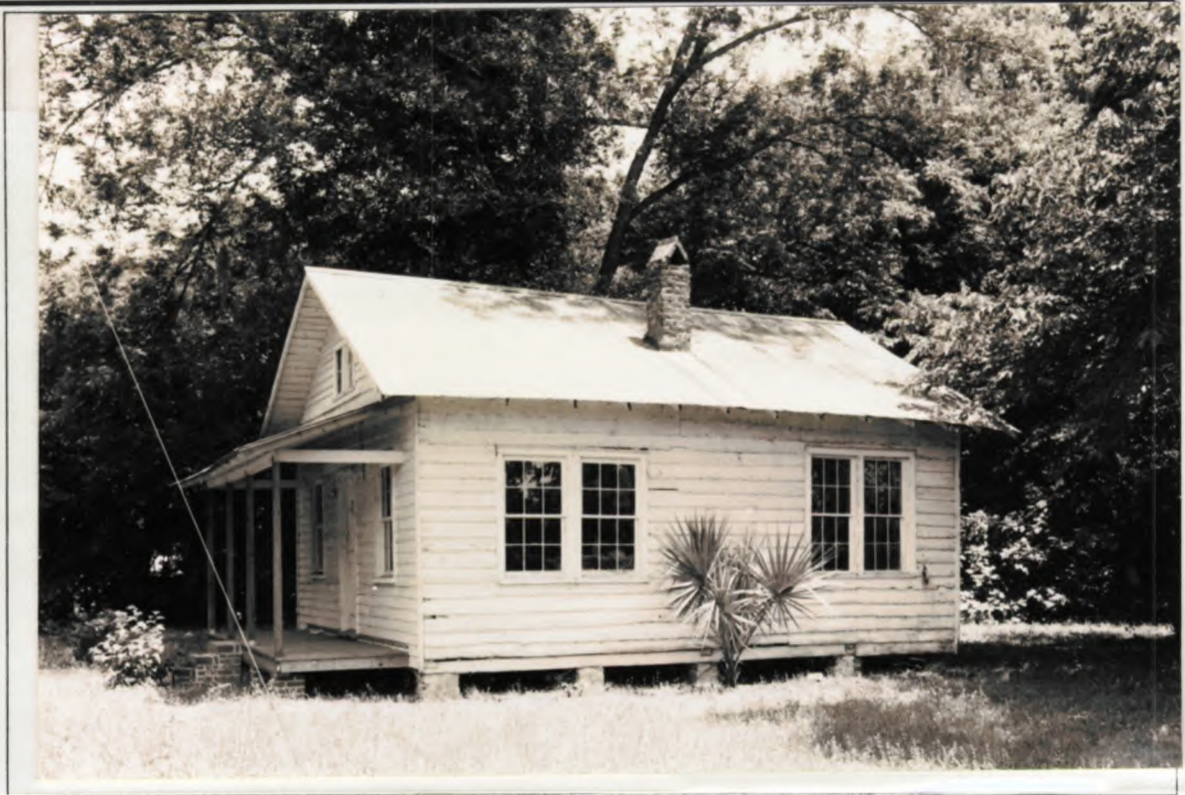
Photograph:

Roll # Neg. View of:
B-09 3 W & S elevs., fac. NE

Alterations: Alteration date: _____ Integrity: good Condition: good

Description: Rectangular 1.5 story frame 3 x 2 bay dwelling w/front facing gable roof; single windows at facade, double at side elevs. ; housed sills
