**BEAUFORT COUNTY  
HISTORIC SITES SURVEY - 1997**

INTENSIVE LEVEL BUILDING INVENTORY FORM

Site Number: U- 13 - 544  
Access County Site #

Historic name(s): \_\_\_\_\_ Map Ref.: PR 12 Tax Number: R110 011 000 0025 0000  
Common name(s): \_\_\_\_\_ City Block Ref.: \_\_\_\_\_ Island: Port Royal Is.  
Address/location: 917 12th St. City/Vicinity of (vic.) Port Royal  
Date: 1925 ca. Alteration date: 1960 ca.  
Ownership:  1. private  2. city  3. county  4. state  5. federal  6. unknown  
Category:  1. building  2. site  3. structure  4. object  
Historic use(s): single dwelling Current uses: single dwelling

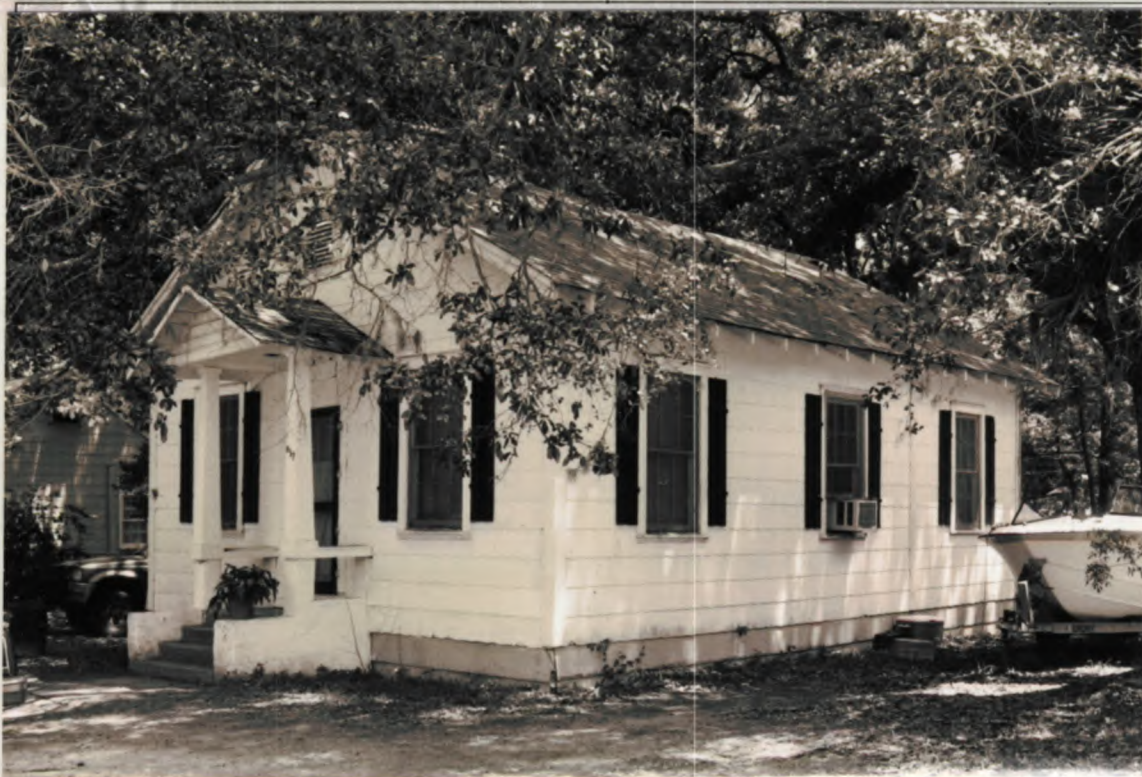
Photograph:

Roll # Neg. View of:  
B-09 7 N & W elev., fac. SE

Style: Folk: gable front Commercial Form: \_\_\_\_\_  
 Core Shape: rectangular Stories: 1 story Construction: frame  
 Roof: Shape: gable (end to front) Material: composition shingle  
 Chimney: Type: interior Material: brick  
 Exterior Walls: asbestos shingle  
 Windows: single Type: double hung Pane 6/6  
 Config.: \_\_\_\_\_  
 Doors: single Foundation: brick piers  
 Porch Height: 1 story Porch Width: entrance bay only Porch Roof Shape: gable  
 Porch Details: posts Decorative Elements: \_\_\_\_\_  
 Outbuildings: Interior Features: \_\_\_\_\_  
 Number of Related Resources: \_\_\_\_\_  
 Surroundings: residential Acreage: \_\_\_\_\_ Quadrangle: Beaufort  
 Alterations: Alteration date: 1960 ca. Integrity: good Condition: good  
 asbestos siding

Description: rectangular 1 story frame dwelling w/front facing gable roof; exposed rafter ends; tapered posts
