**BEAUFORT COUNTY
HISTORIC SITES SURVEY - 1997**

INTENSIVE LEVEL BUILDING INVENTORY FORM

Site Number: U- 13 - 568
Access County Site #
 USGS Quad: 025 Beaufort
 Doc. Level: Intensive Level-Building

Historic name(s): _____ Map Ref.: PR 11 Tax Number: R110 010 000 145A 0000
 Common name(s): _____ City Block Ref.: _____ Island: Port Royal Is.
 Address/location: 1010 14th St. City/Vicinity of (vic.): Port Royal
 Date: 1900 ca. Alteration date: 1960 c.
 Ownership: 1. private 2. city 3. county 4. state 5. federal 6. unknown
 Category: 1. building 2. site 3. structure 4. object
 Historic use(s): single dwelling Current uses: single dwelling

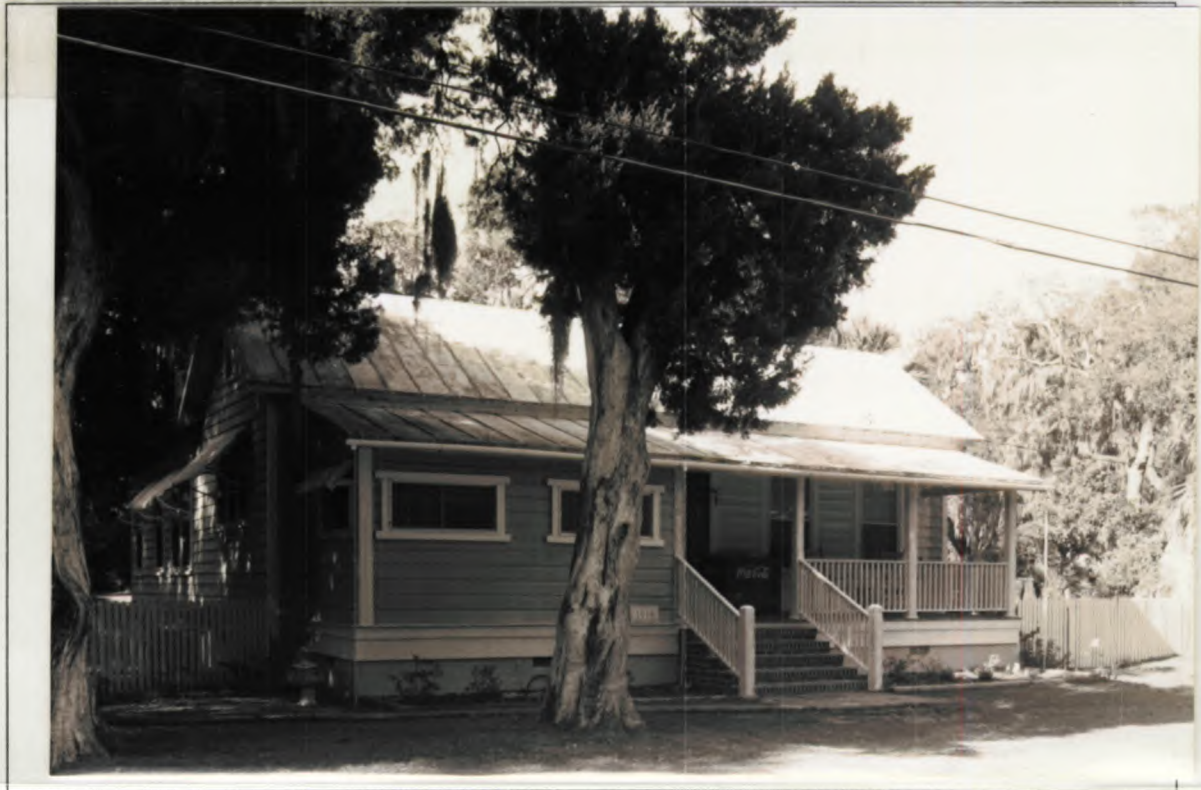
Roll # B-08 Neg. 5 View of: S facade & W elev., fac. NE

Alterations: Alteration date: 1960 c. Integrity: good Condition: good
 Infill at porch, infill and stucco at foundation, rear addition, side windows.

Description: Rectangular 5 x 1 bay frame 1 story dwelling w/lateral gable raised seam metal roof and full facade porch; rear full-width 3-bay deep shed addition. Western 2 bays of porch now infilled. Remaining bay s of porch retain chamfered posts & slat balustrade. Central entrance at facade w/two 6/6 windows to the E. Side elevations have replacement windows and rectangular louvered attic vents
