**BEAUFORT COUNTY  
HISTORIC SITES SURVEY - 1997**

INTENSIVE LEVEL BUILDING INVENTORY FORM

Site Number: U- 13 - 601  
Access County Site #  
USGS Quad: 025 Beaufort  
Doc. Level: Intensive Level-Building

Historic name(s): \_\_\_\_\_ Map Ref.: PR 07 - BFT Tax Number: R110 009 000 0105 0000  
Common name(s): \_\_\_\_\_ City Block Ref.: \_\_\_\_\_ Island: Port Royal Is.  
Address/location: 1680 rear Ribaut Rd. City/Vicinity of (vic.) Port Royal  
Date: 19th c., late Alteration date: 1950 ca.  
Ownership:  1. private  2. city  3. county  4. state  5. federal  6. unknown  
Category:  1. building  2. site  3. structure  4. object  
Historic use(s): single dwelling Current uses: single dwelling

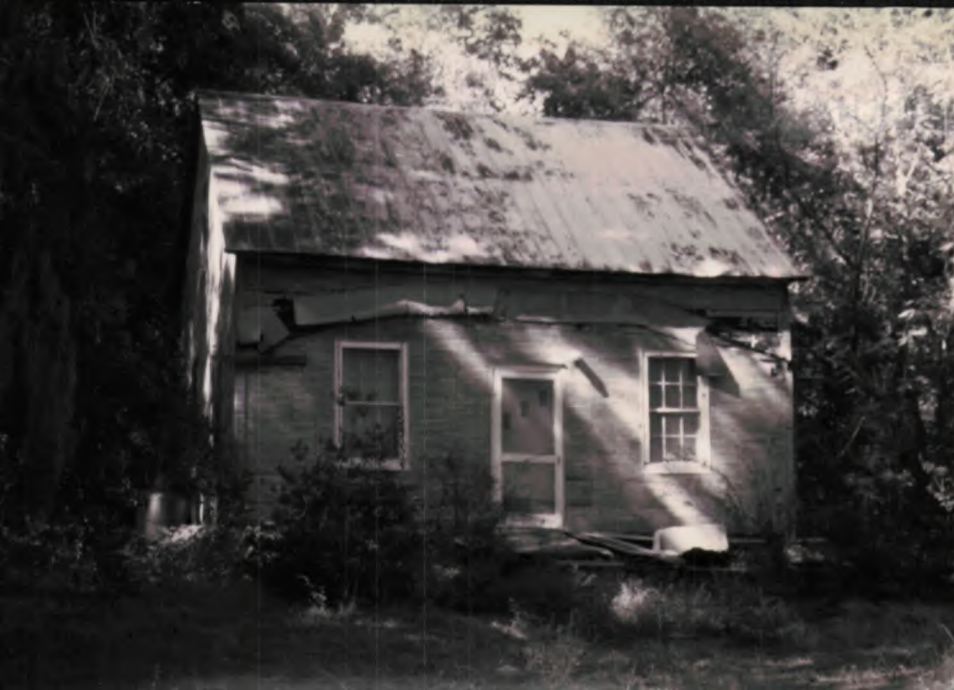
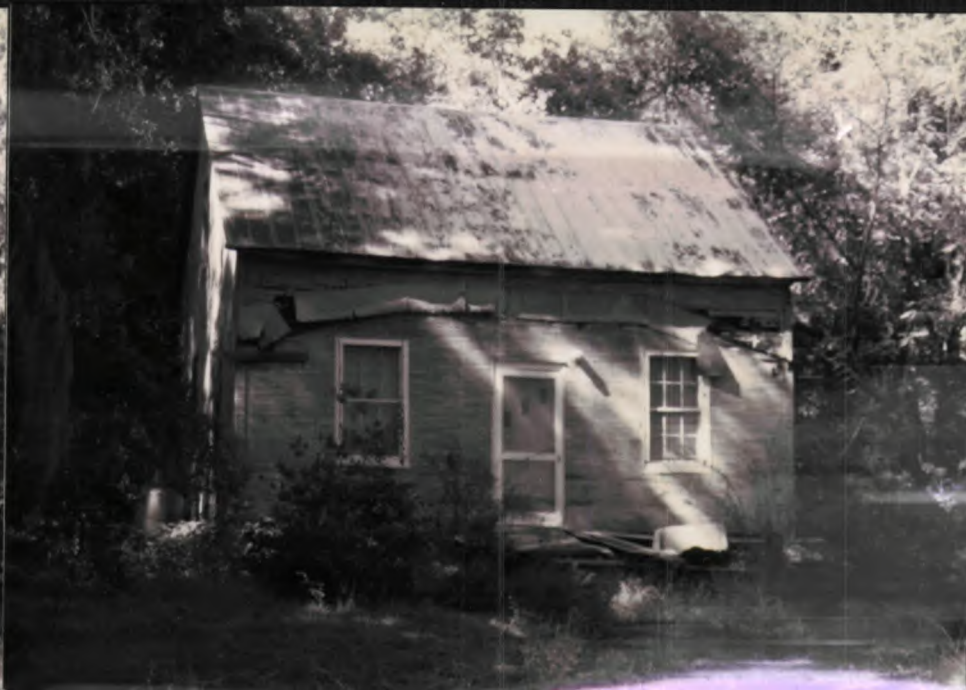
Roll # Neg. View of:  
S-08 5 S & W elevs.  
S-08 6 Dupe

Alterations: Alteration date: 1950 ca. Integrity: fair Condition: deteriorated  
 V-crimped metal roofing; composition shingle siding over historic wood siding; front porch removed

Description: Rectangular 3 x 2 bay dwelling w/lateral gable roof; former hipped porch at facade now removed, ghost of roof structure remains visible; 1-story porch rear entrance porch; boxed cornice; one interior chimney visible at west end of rear (north) slope of roof; surveyor was not able to access rear of property to document fenestration at the rear elevation nor to look for second chimney; surveyor was not able to access the interior; chimney placement indicates massed plan, with possible central hall
