**BEAUFORT COUNTY
HISTORIC SITES SURVEY - 1997**

INTENSIVE LEVEL BUILDING INVENTORY FORM

Site Number: U- 13 - 26.01
Access County Site #
USGS Quad: 445 Saint Phillips Island
Doc. Level: Intensive Level-Building

Historic name(s): Frogmore Plantation Map Ref.: _____ Tax Number: R300 023 000 0231 0000
Common name(s): _____ City Block Ref.: _____ Island: St. Helena Is.
Address/location: 59 Sassafrass Drive City/Vicinity of (vic.): St. Helena Island
Date: 1835 ca. Alteration date: _____
Ownership: 1. private 2. city 3. county 4. state 5. federal 6. unknown
Category: 1. building 2. site 3. structure 4. object
Historic use(s): barn Current uses: barn

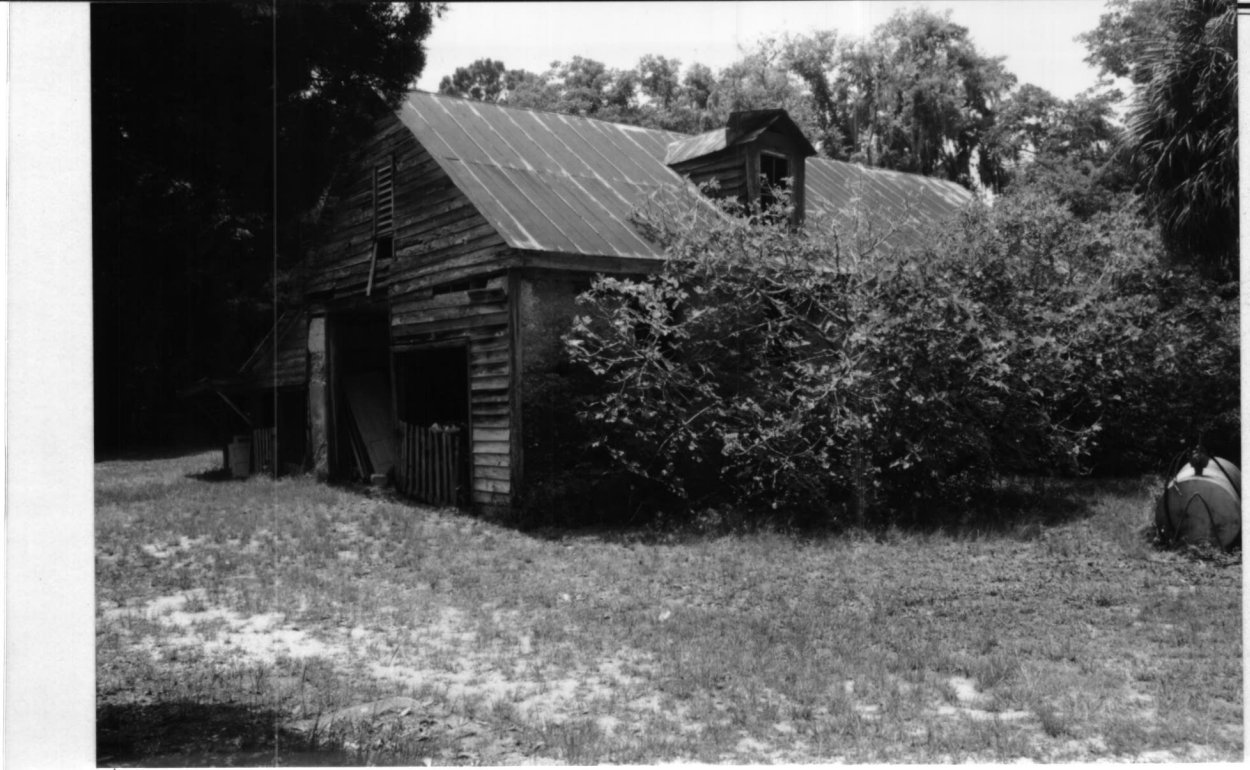
Photograph:

Alterations: _____ Alteration date: _____ Integrity: good Condition: fair

Description: Rectangular barn, tabby walls with wooden structure over. Central aisle, with 4 stalls on one side, walls also built of tabby
