**BEAUFORT COUNTY  
HISTORIC SITES SURVEY - 1997**

INTENSIVE LEVEL BUILDING INVENTORY FORM

Historic name(s): Hunting Island Lighthouse Complex Map Ref.: \_\_\_\_\_ Tax Number: R300 011 000 0010 0000  
Common name(s): \_\_\_\_\_ City Block Ref.: \_\_\_\_\_ Island: St. Helena Is.  
Address/location: Hunting Island State Park City/Vicinity of (vic.) St. Helena Island vic.  
Date: 1889 ca. Alteration date: \_\_\_\_\_  
Ownership:  1. private  2. city  3. county  4. state  5. federal  6. unknown  
Category:  1. building  2. site  3. structure  4. object  
Historic use(s): storage Current uses: visitor center

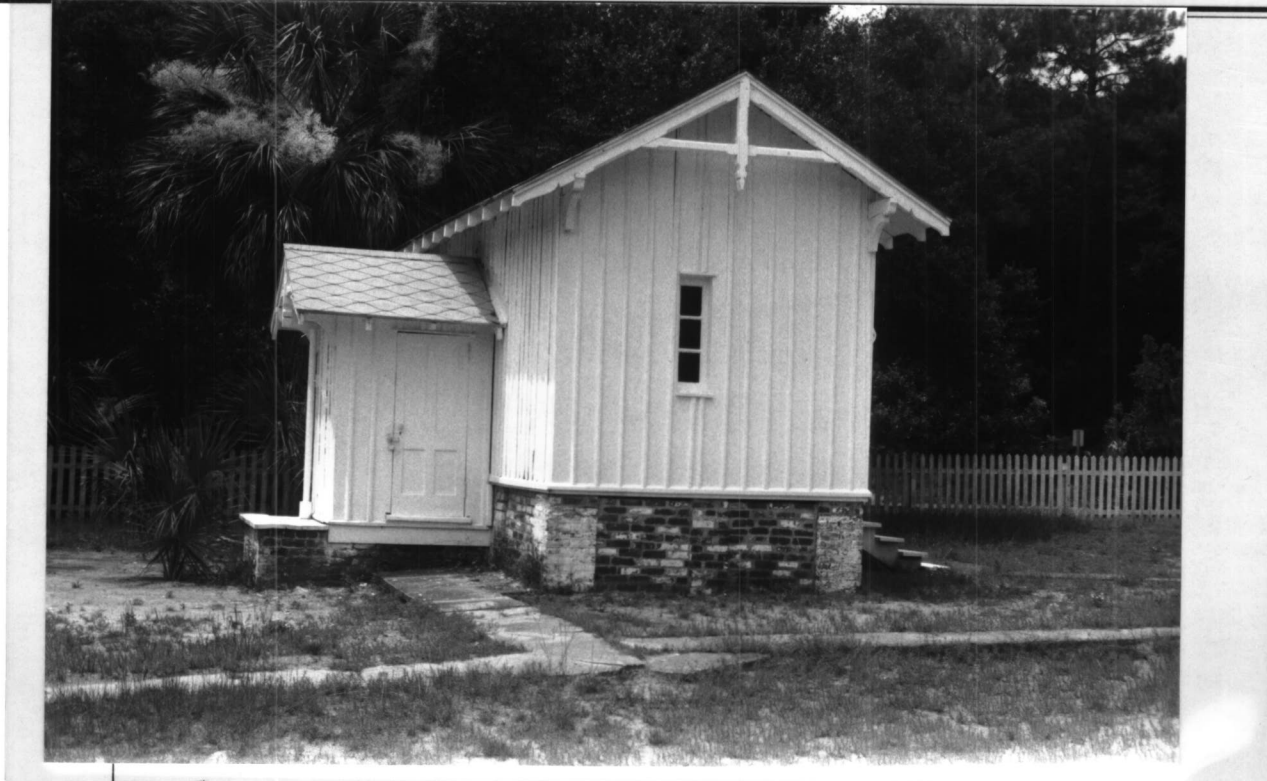
Roll # Neg. View of:  
H-18 8 nw oblique

Alterations: Alteration date: \_\_\_\_\_ Integrity: good Condition: excellent

Description: Small one or two room building with exposed shaped rafter tails. Low gabled enclosed entrance porch projects from long side. Gable trim at each end.
