**BEAUFORT COUNTY
HISTORIC SITES SURVEY - 1997**

INTENSIVE LEVEL BUILDING INVENTORY FORM

Site Number: U- 13 - 290.01
Access County Site #
USGS Quad: 470 Sheldon
Doc. Level: Intensive Level-Building

Historic name(s): Brays Island Map Ref.: _____ Tax Number: R700.025.000.0001.0000
Common name(s): Administration Office City Block Ref.: _____ Island: _____
Address/location: 221 Brays Island Drive City/Vicinity of (vic.) Sheldon vic.
Date: 1945 ca. Alteration date: 1950 ca.
Ownership: 1. private 2. city 3. county 4. state 5. federal 6. unknown
Category: 1. building 2. site 3. structure 4. object
Historic use(s): single dwelling Current uses: office

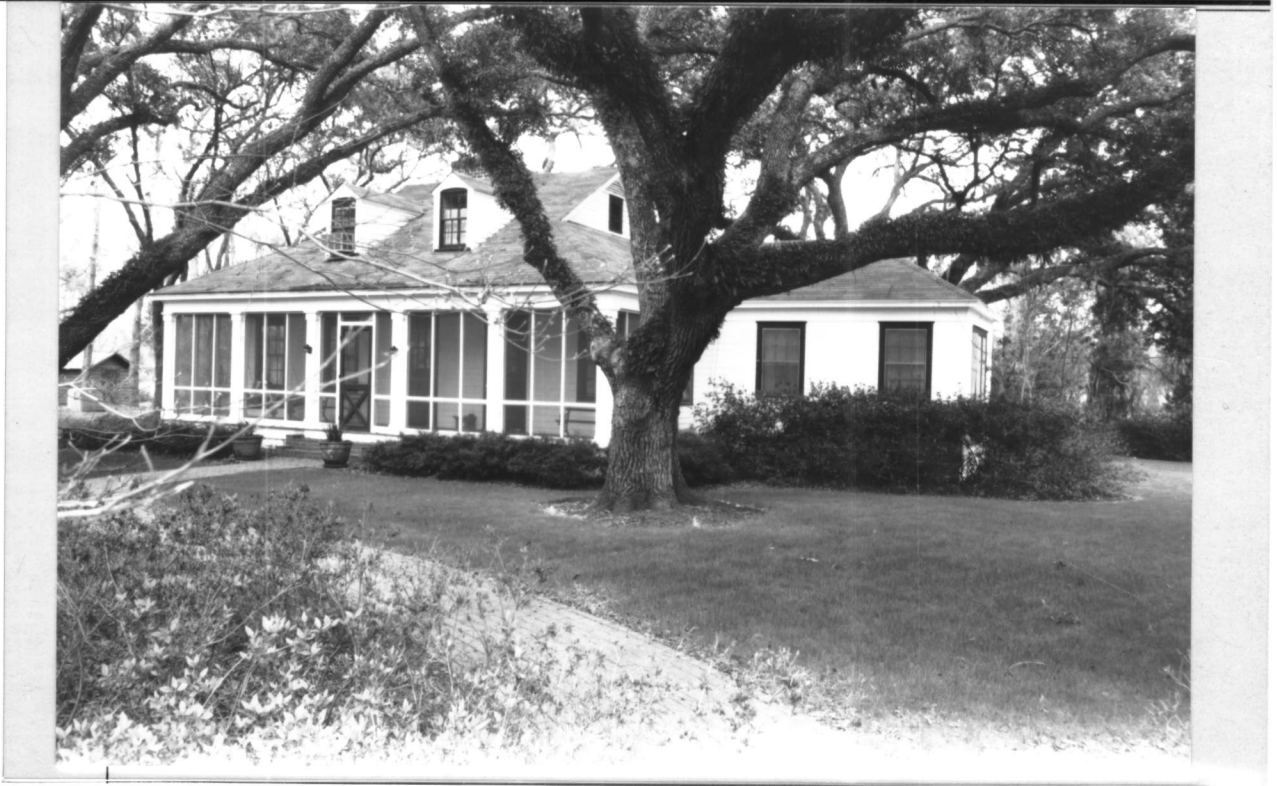
Roll # Neg. View of:
H-5 16 nw oblique

Alterations: Alteration date: 1950 ca. Integrity: good Condition: excellent
rear recessed corner porch enclosed with ship-lap

Description: Side gable/hip roof, 2 dormers on roof. 1-story hip-roof projection on right
