**BEAUFORT COUNTY
HISTORIC SITES SURVEY - 1997**

INTENSIVE LEVEL BUILDING INVENTORY FORM

Site Number: U- 13 - 290.05
Access County Site #
USGS Quad: 470 Sheldon
Doc. Level: Intensive Level-Building

Historic name(s): Brays Island Map Ref.: _____ Tax Number: R700 025 000 0001 0000
Common name(s): _____ City Block Ref.: _____ Island: _____
Address/location: Brays Island Drive City/Vicinity of (vic.) Sheldon vic.
Date: 1945 ca. Alteration date: 1950 ca.
Ownership: 1. private 2. city 3. county 4. state 5. federal 6. unknown
Category: 1. building 2. site 3. structure 4. object
Historic use(s): single dwelling Current uses: unknown

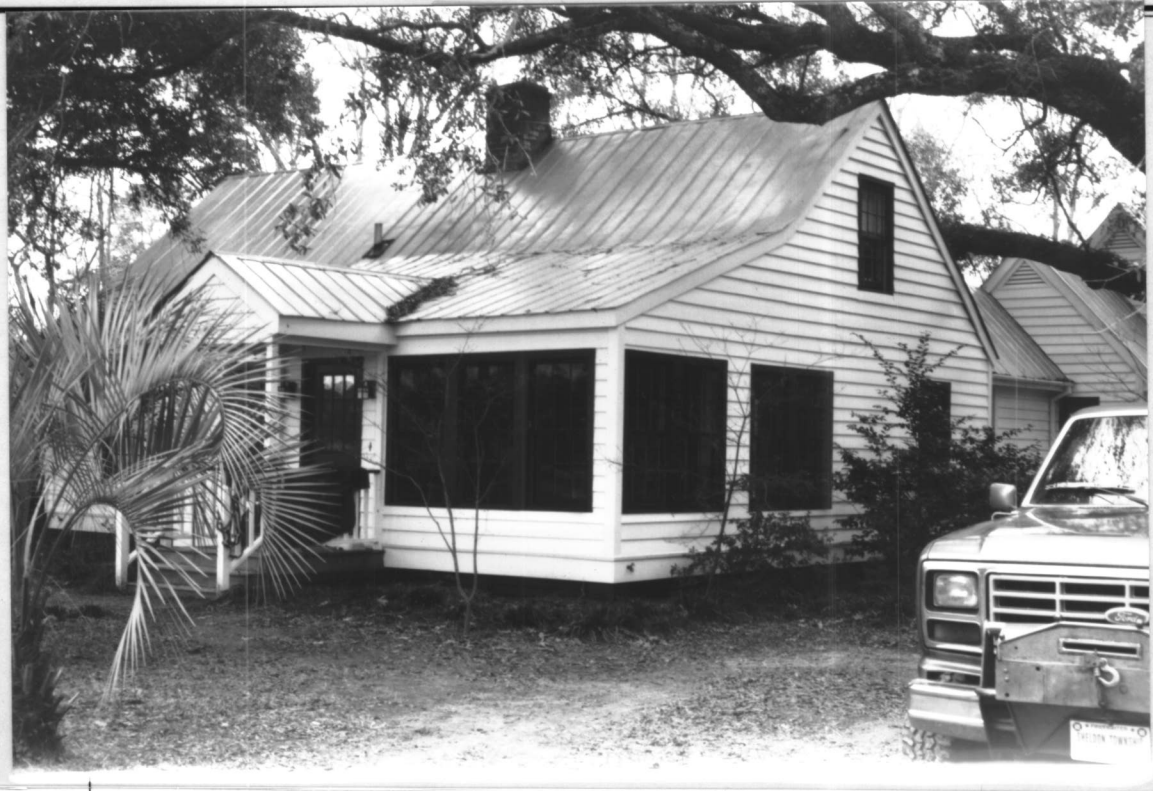
Photograph:

Roll # Neg. View of:
H-5 20 nw oblique

Alterations: Alteration date: 1950 ca. Integrity: fair Condition: good

Description: Originally a 5-bay side gable house. Off-center front porch now enclosed under engaged roof, with small gable covering now extending from off-center front door. Series of additions to right rear.
