**BEAUFORT COUNTY
HISTORIC SITES SURVEY - 1997**

INTENSIVE LEVEL BUILDING INVENTORY FORM

Historic name(s): Penn Center Historic District Map Ref.: _____ Tax Number: R300 016 000 0094 0000
Common name(s): Darrah Hall City Block Ref.: _____ Island: St. Helena Is.
Address/location: 24 Penn Center Circle City/Vicinity of (vic.) St. Helena Island
Date: 1882 Alteration date: 1996
Ownership: 1. private 2. city 3. county 4. state 5. federal 6. unknown
Category: 1. building 2. site 3. structure 4. object
Historic use(s): meeting hall Current uses: meeting hall

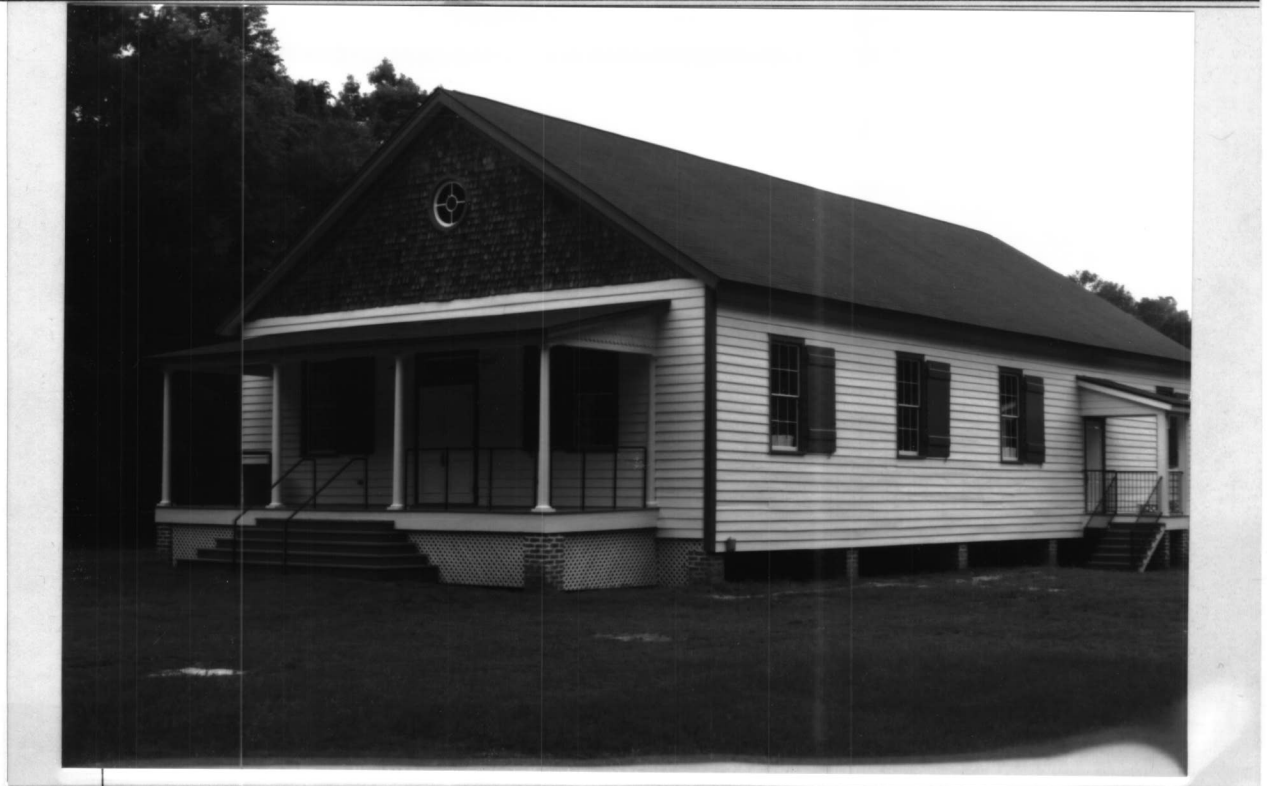
Roll # Neg. View of:
H-16 24A northeast oblique

Alterations: Alteration date: 1996 Integrity: fair Condition: excellent

Reconstructed from original materials.

Description: Rectangular gable-front church. 3 bay facade features central double door. 5 bays along each side; single door entrance at 4th bay on right side. Front gable features fish-scale shingles and bulls eye window. Wooden shutter at each window.
