**BEAUFORT COUNTY
HISTORIC SITES SURVEY - 1997**

INTENSIVE LEVEL BUILDING INVENTORY FORM

Historic name(s): Penn Center Historic District Map Ref.: _____ Tax Number: R300 016 000 0094 0000
Common name(s): Orchard Cottage City Block Ref.: _____ Island: St. Helena Is.
Address/location: 11 Penn Center Road City/Vicinity of (vic.) St. Helena Island
Date: 1942 Alteration date: _____
Ownership: 1. private 2. city 3. county 4. state 5. federal 6. unknown
Category: 1. building 2. site 3. structure 4. object
Historic use(s): single dwelling Current uses: single dwelling

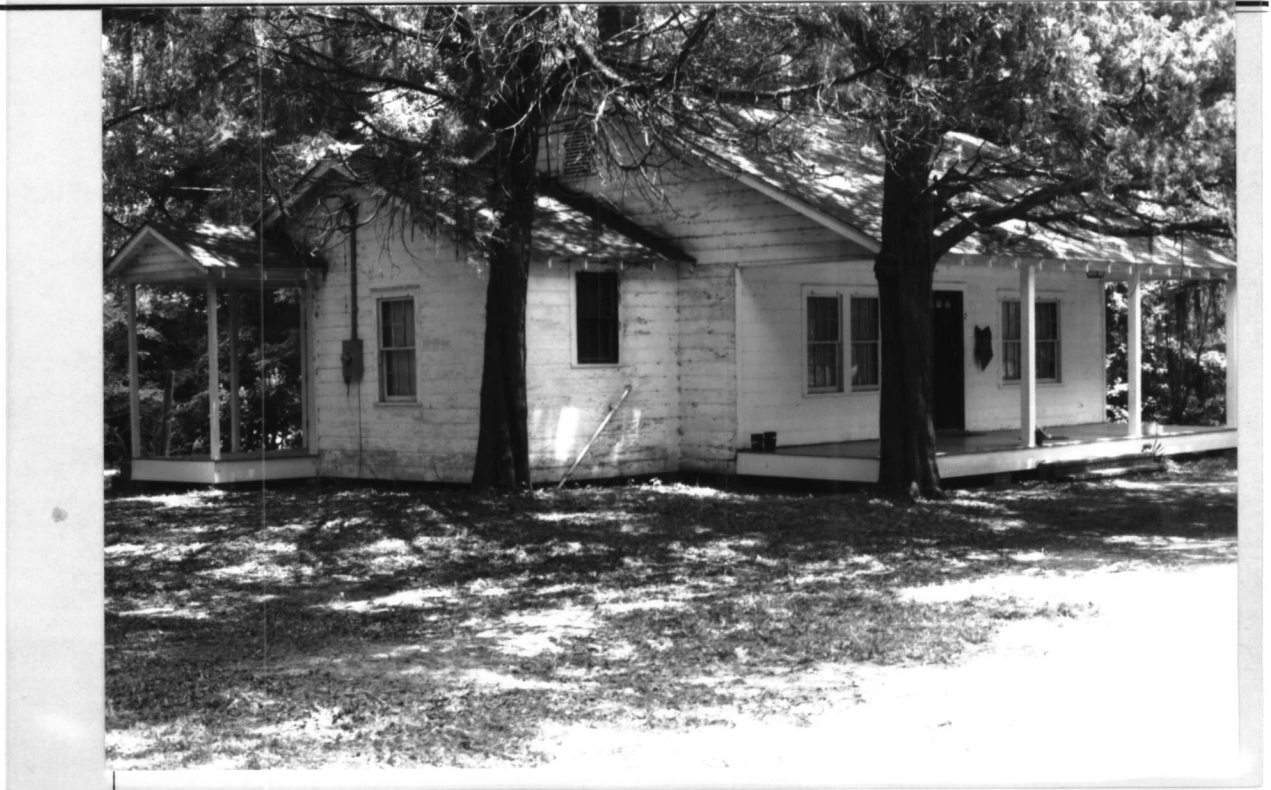
Roll # Neg. View of:
H-17 12 sw oblique

Alterations: Alteration date: _____ Integrity: fair _____ Condition: fair _____
 One room addition to left side.

Description: Low irregular house. Perhaps had once been a one-room house, now extended under a common roof. 3 bay facade with a central door. Porch recessed under overhanging eave.
