**BEAUFORT COUNTY
HISTORIC SITES SURVEY - 1997**

INTENSIVE LEVEL BUILDING INVENTORY FORM

Historic name(s): Lady's Island Baptist Church Map Ref.: _____ Tax Number: R200 010 000 0039 0000
Common name(s): _____ City Block Ref.: _____ Island: Lady's Is.
Address/location: 111 Brickyard Point Road North City/Vicinity of (vic.) Lady's Island
Date: 1855 ca. Alteration date: 1925 ca.
Ownership: 1. private 2. city 3. county 4. state 5. federal 6. unknown
Category: 1. building 2. site 3. structure 4. object
Historic use(s): Church Current uses: Church

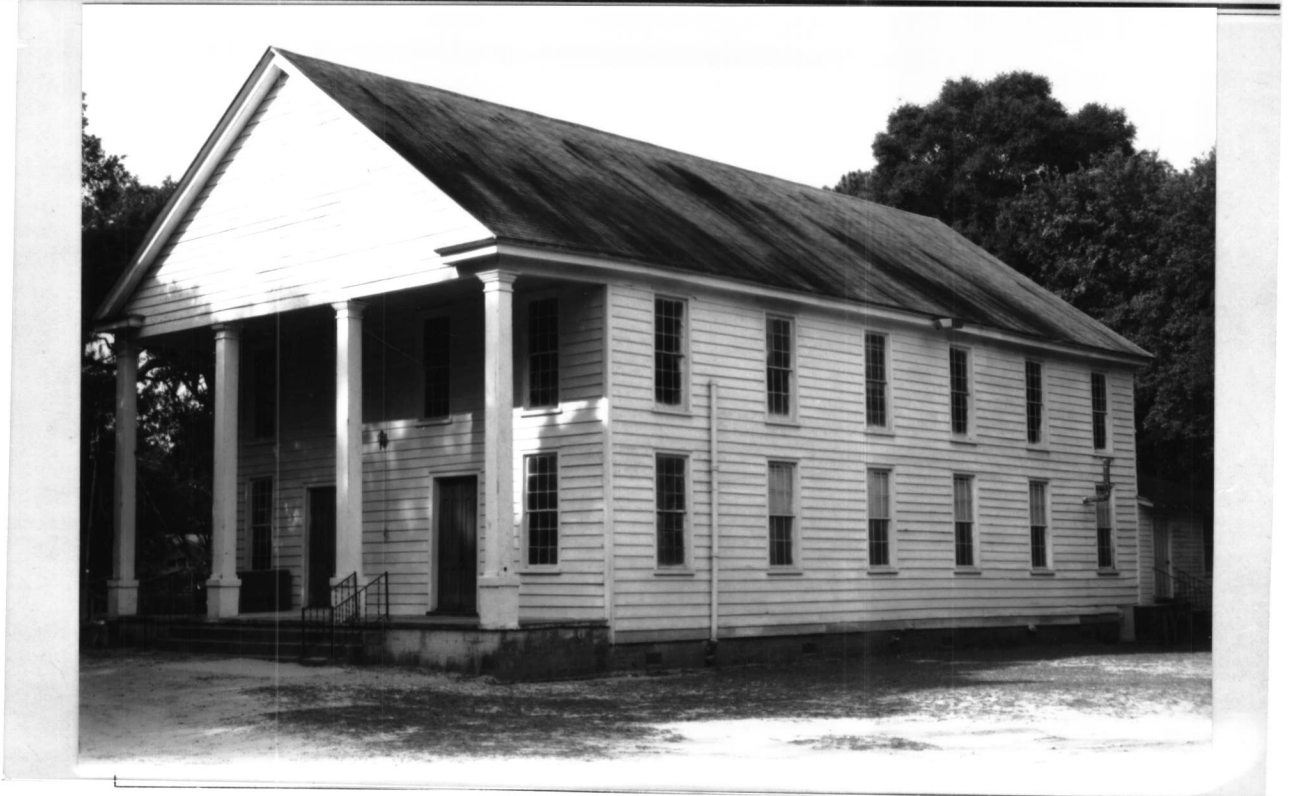
Photograph: _____

Roll # Neg. View of:
H-11 2 ne oblique
103 5 pediment detail

Alterations: Alteration date: 1925 ca. Integrity: excellent Condition: good
1-room, 1-story addition to rear, features exposed rafter tails.

Description: Large 2-story temple front church. 4-bay facade; first floor unevenly spaced with 2 windows and 2 double doors. Second story has 4 evenly spaced windows. Porch formed by gable projecting beyond facade to form temple front; supported by 4 tall square wooden posts set on short masonry piers. Returned eaves on front. 6 window bays deep on side.
