**BEAUFORT COUNTY
HISTORIC SITES SURVEY - 1997**

INTENSIVE LEVEL BUILDING INVENTORY FORM

Site Number: U- 13 - 43
Access County Site #
USGS Quad: 182 Frogmore
Doc. Level: Intensive Level-Building

Historic name(s): St. Helena's Church Chapel of Ease Map Ref.: _____ Tax Number: R300 023 000 0096 0000
Common name(s): _____ City Block Ref.: _____ Island: St. Helena Is.
Address/location: 17 Lands End Road City/Vicinity of (vic.) St. Helena Island
Date: 1750 ca. Alteration date: _____
Ownership: 1. private 2. city 3. county 4. state 5. federal 6. unknown
Category: 1. building 2. site 3. structure 4. object
Historic use(s): church Current uses: abandoned

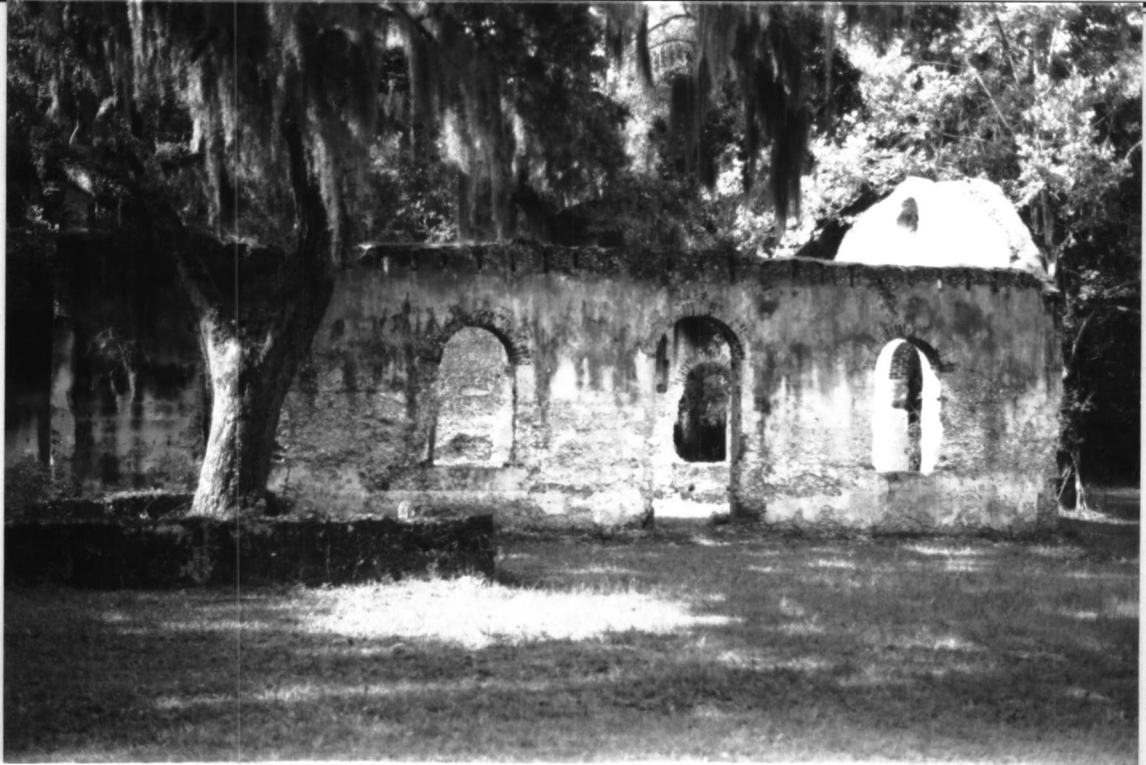
Photograph:

Roll # Neg. View of:
H-15 3 northwest, Chapel

Alterations: Alteration date: _____ Integrity: good Condition: ruin
 Destroyed by fire 1886

Description: Four walls remaining, tabby construction with brick arches. Three bays facade, central door with flanking windows. Sides--four bays, offcenter doorway at 2nd bay. Lines of porch visible on front. Truncated pediment remains, with bull's eye window. Sandstone mausoleum to side with Egyptian detailing.
