**BEAUFORT COUNTY  
HISTORIC SITES SURVEY - 1997**

INTENSIVE LEVEL BUILDING INVENTORY FORM

Historic name(s): Burlington Plantation Map Ref.: \_\_\_\_\_ Tax Number: R100 024 0042 0000  
Common name(s): \_\_\_\_\_ City Block Ref.: \_\_\_\_\_ Island: \_\_\_\_\_  
Address/location: off Joe Frazier Road City/Vicinity of (vic.) Beaufort vic.  
Date: 1750 ca. Alteration date: \_\_\_\_\_  
Ownership:  1. private  2. city  3. county  4. state  5. federal  6. unknown  
Category:  1. building  2. site  3. structure  4. object  
Historic use(s): Indigo vat Current uses: Abandoned

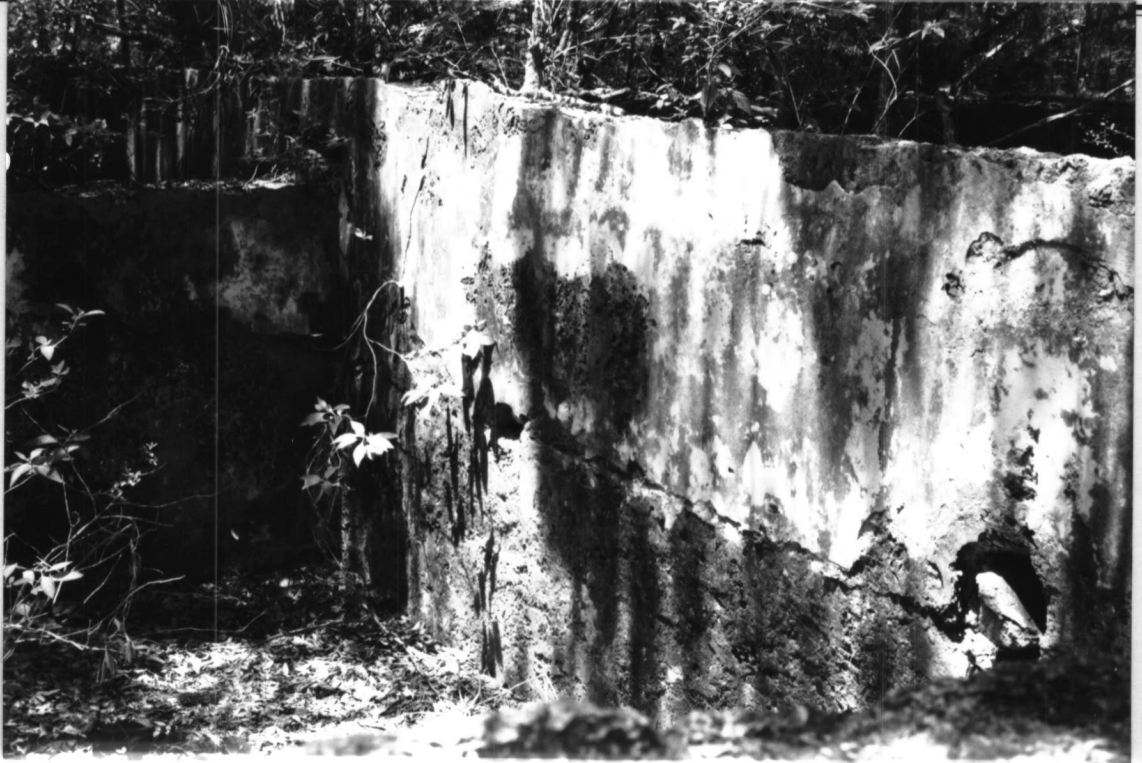
Photograph:

Alterations: Alteration date: \_\_\_\_\_ Integrity: **excellent** Condition: **fair**

Description: 4-part indigo vat. Two sets of compartments, one set c. 2 feet higher than the other set. Tabby construction, 2 base courses and one top course visible. Tabby surface has been coated in c. 3/4 inch tabby slurry, then hard plaster coat above that. Drains that connect that compartments remain visible. Compartments now partially filled with detritus, trees growing out.
