**BEAUFORT COUNTY
HISTORIC SITES SURVEY - 1997**

INTENSIVE LEVEL BUILDING INVENTORY FORM

Site Number: U- 13 - 471
Access County Site #

Address/location: 870 M.L. King Jr. Blvd. and Sea Island Pkwy City/Vicinity of (vic.) St. Helena Island

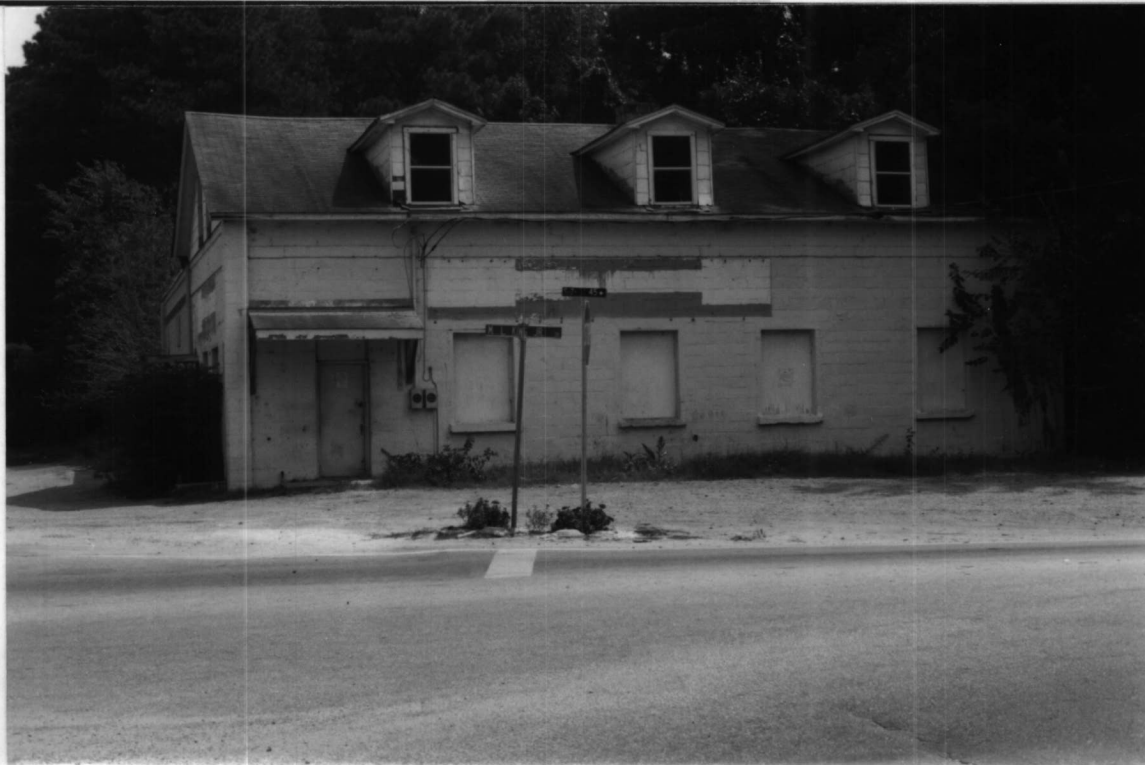
Photograph:

Roll #	Neg.	View of:
H-19	12	nw oblique

Alterations: Alteration date: 1970 ca Integrity: fair Condition: fair
Large 1-story section added to rear.

Description: Large 1.5 story concrete block building. 5-bay facade, single door the farthest left. Three peaked dormer windows across roof. Corners accentuated with projecting cement blocks. Bracketed shed roof covering door.
