**BEAUFORT COUNTY
HISTORIC SITES SURVEY - 1997**

INTENSIVE LEVEL BUILDING INVENTORY FORM

Historic name(s): Tomotley Plantation Map Ref.: _____ Tax Number: R700 0013 000 0001
Common name(s): _____ City Block Ref.: _____ Island: _____
Address/location: off Old Sheldon Road City/Vicinity of (vic.) Gardens Corner vic.
Date: 1910 Alteration date: 1912 ca; 1990
Ownership: 1. private 2. city 3. county 4. state 5. federal 6. unknown
Category: 1. building 2. site 3. structure 4. object
Historic use(s): single dwelling Current uses: single dwelling

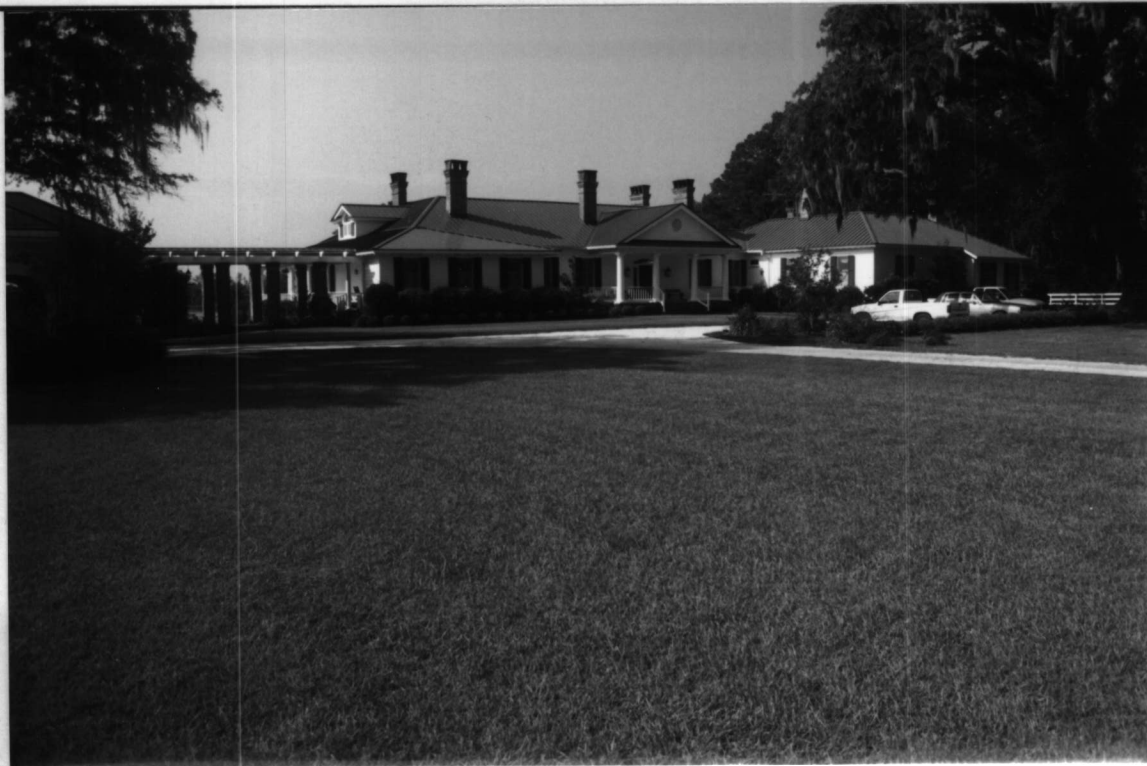
Photograph:

Projecting section on right built shortly after the main house was constructed. Current owner created new front door and portico; previous entrance had been a small door to the left of the current door.

Description: Sprawling, generally Mission style house. Rectangular central block with off-center front entrance under a pedimented portico. Uneven projecting sections at each end, each with hip roof. Pergola connects house with 3-bay garage on left side. Seven brick chimneys with corbelling and caps project from roof. Overhanging eaves with decorative rafter tails.
