**BEAUFORT COUNTY
HISTORIC SITES SURVEY - 1997**

INTENSIVE LEVEL BUILDING INVENTORY FORM

Site Number: U- 13 - 481.03
Access County Site #
USGS Quad: 470 Sheldon
Doc. Level: Intensive Level-Building

Historic name(s): Tomotley Plantation Map Ref.: _____ Tax Number: R700 0013 000 0001
Common name(s): _____ City Block Ref.: _____ Island: _____
Address/location: off Old Sheldon Road City/Vicinity of (vic.) Gardens Corner vic.
Date: 1910 Alteration date: _____
Ownership: 1. private 2. city 3. county 4. state 5. federal 6. unknown
Category: 1. building 2. site 3. structure 4. object
Historic use(s): single dwelling Current uses: single dwelling

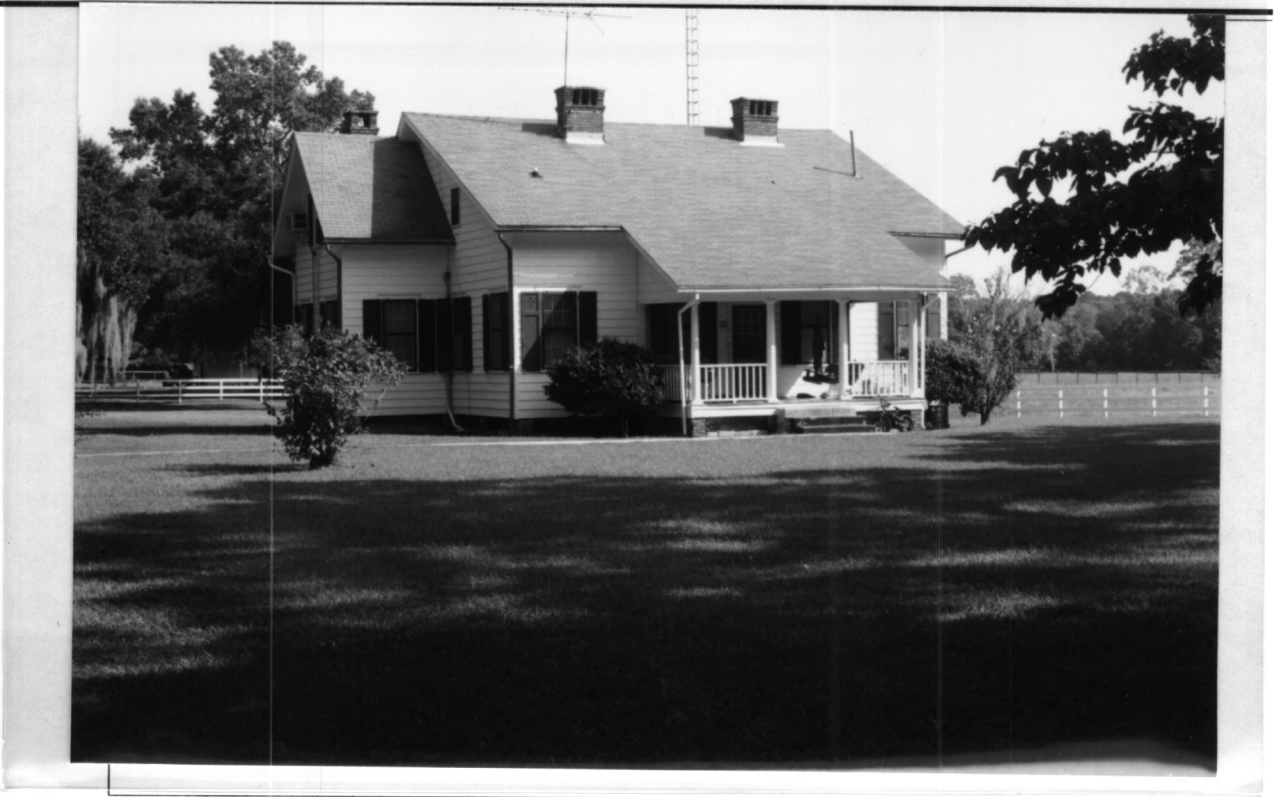
Photograph:

Roll # Neg. View of:
H-20 7 sw oblique

Description: Small house with long, Craftsman-like side gable roof. Roof extends beyond eave line at center to form the porch. Two interior chimneys with brick cap and corbels. Five bay facade with central door. Wing extends from left side rear with a separate side gable roof, perhaps an addition.
