**BEAUFORT COUNTY
HISTORIC SITES SURVEY - 1997**

INTENSIVE LEVEL BUILDING INVENTORY FORM

Historic name(s): Tomotley Plantation Map Ref.: _____ Tax Number: R700 0013 000 0001
Common name(s): _____ City Block Ref.: _____ Island: _____
Address/location: off Old Sheldon Road City/Vicinity of (vic.) Gardens Corner vic.
Date: 1910 Alteration date: _____
Ownership: 1. private 2. city 3. county 4. state 5. federal 6. unknown
Category: 1. building 2. site 3. structure 4. object
Historic use(s): barn Current uses: barn

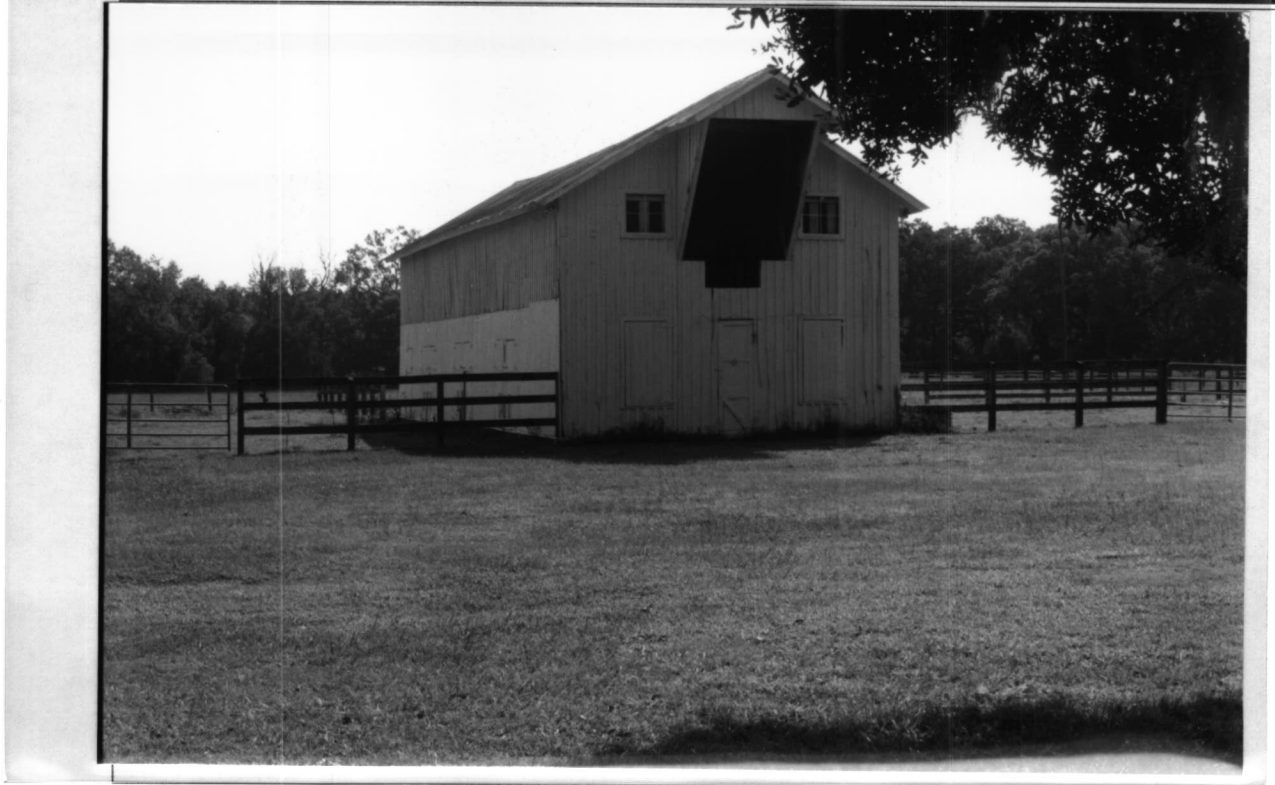
Photograph:

Roll # Neg. View of:
H-20 9 nw oblique

Alterations: Alteration date: _____ Integrity: good Condition: excellent

Description: Long narrow barn. Roof peak extends beyond the facade to form a cover for large second floor opening. Central single wooden door on first floor, surrounded by two window openings covered with a wooden shutter.
