**BEAUFORT COUNTY
HISTORIC SITES SURVEY - 1997**

INTENSIVE LEVEL BUILDING INVENTORY FORM

Historic name(s): Prince Williams Parish Church Map Ref.: _____ Tax Number: R700 019 000 0130 0000
Common name(s): Old Sheldon Church City Block Ref.: _____ Island: _____
Address/location: 919 Old Sheldon Church Road City/Vicinity of (vic.) Sheldon vic.
Date: 1750 ca. Alteration date: _____
Ownership: 1. private 2. city 3. county 4. state 5. federal 6. unknown
Category: 1. building 2. site 3. structure 4. object
Historic use(s): church Current uses: _____

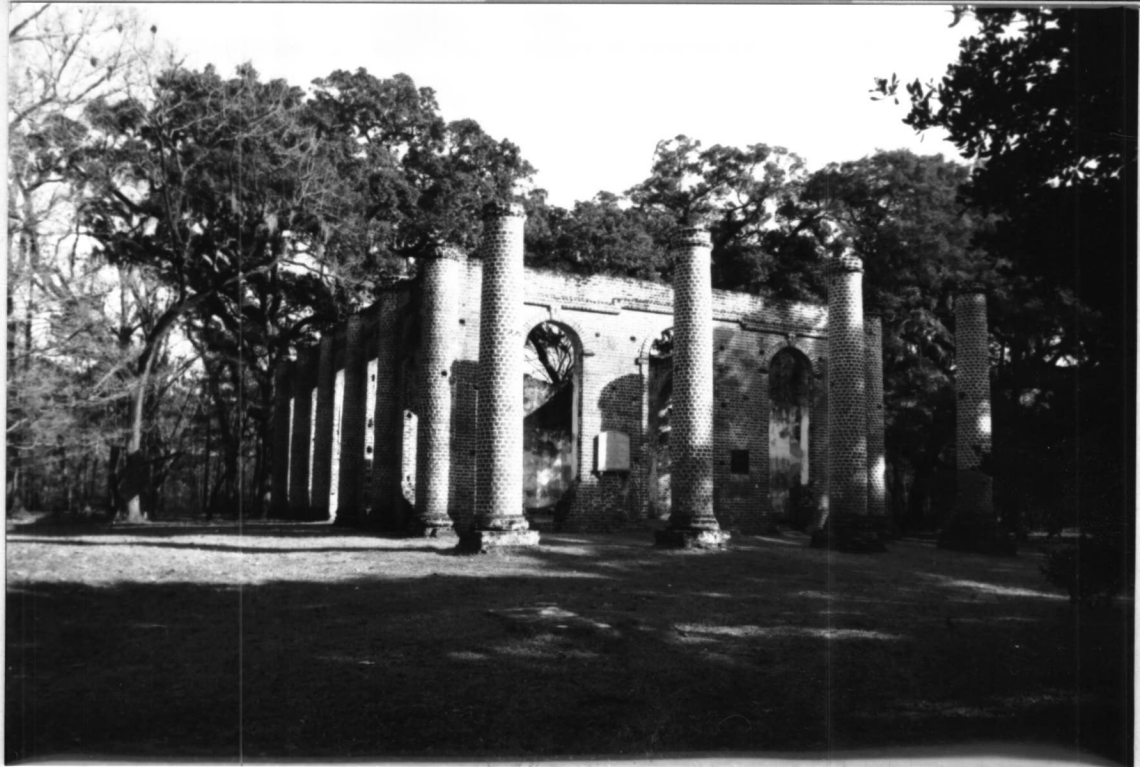
Roll # Neg. View of:
H-1 19 sw oblique

Alterations: Alteration date: _____ Integrity: good Condition: ruin

Description: Ruins of a church; 4 walls, and porch columns, remain. No roof. 2 window openings on the front, 5 each on the sides. Window tops feature arched bricks. Two doorways--center front and center rear. Stepped up brick sections at top plate between window openings. 4 free-standing brick columns across the front, set on square brick bases. Exterior side walls feature pilasters between window bays. Diapered bricks on front, between bays.
