**BEAUFORT COUNTY
HISTORIC SITES SURVEY - 1997**

INTENSIVE LEVEL BUILDING INVENTORY FORM

Site Number: U- 13 - 501
Access County Site #
USGS Quad: 025 Beaufort
Doc. Level: Intensive Level-Building

Historic name(s): _____ Map Ref.: PR 12 Tax Number: R110 011 000 0261 0000
Common name(s): _____ City Block Ref.: _____ Island: Port Royal Is.
Address/location: 911 7th St. City/Vicinity of (vic.): Port Royal
Date: 1900 Alteration date: _____
Ownership: 1. private 2. city 3. county 4. state 5. federal 6. unknown
Category: 1. building 2. site 3. structure 4. object
Historic use(s): single dwelling Current uses: commercial

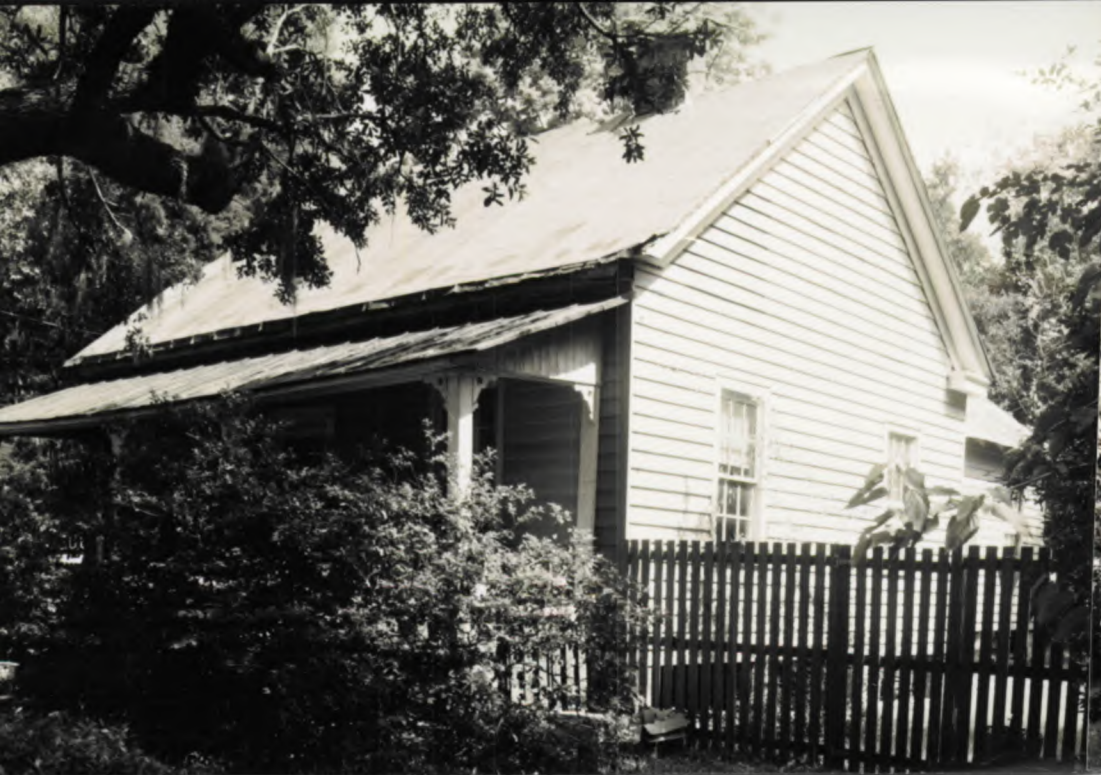
ROLL & FRAME CB 8/8 10

Roll # Neg. View of:
B-08 9 N facade & W elev., fac. SE
B-08 10 N facade, fac. S

Description: Rectangular 1 story 3 x 2 bay frame dwelling w/lateral gable raised seam metal roof. 1-story T wing at rear. Boxed cornice. Shed porch across facade w/beaded board siding at ends, posts w/sawn brackets. Central entrance at facade flanked by 6/6 double hung sash windows. Two 6/6 windows at each side elevation.
