**BEAUFORT COUNTY  
HISTORIC SITES SURVEY - 1997**

INTENSIVE LEVEL BUILDING INVENTORY FORM

Site Number: U- 13 - 514  
Access County Site #

Historic name(s): \_\_\_\_\_ Map Ref.: PR 12 Tax Number: R110 011.000 060B 0000  
Common name(s): \_\_\_\_\_ City Block Ref.: \_\_\_\_\_ Island: Port Royal Is.  
Address/location: 906 8th St. City/Vicinity of (vic.) Port Royal  
Date: 1900 ca. Alteration date: 1970 ca.  
Ownership:  1. private  2. city  3. county  4. state  5. federal  6. unknown  
Category:  1. building  2. site  3. structure  4. object  
Historic use(s): single dwelling Current uses: single dwelling

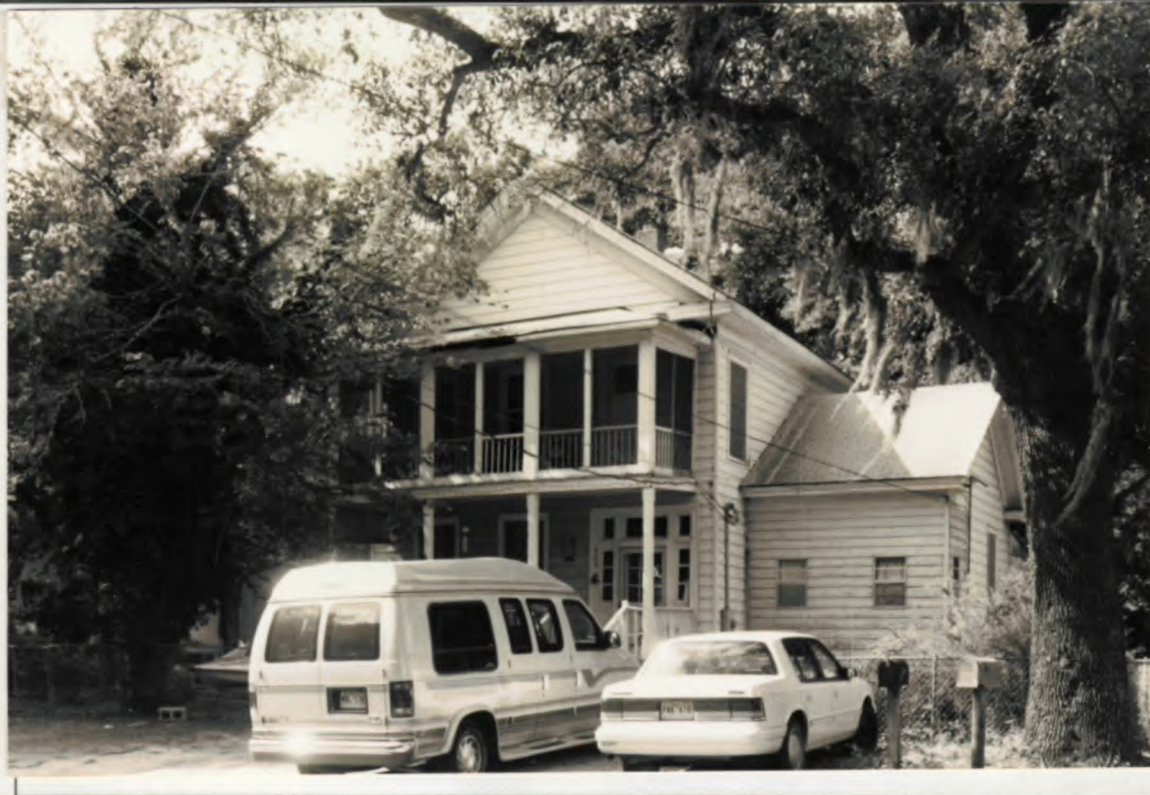
Photograph:

Roll # Neg. View of:  
B-08 15 S facade & E elev., fac. NW

Alterations: Alteration date: 1970 ca. Integrity: \_\_\_\_\_ Condition: good  
 Synthetic siding, porch screening, porch infill @ wing

Description: 2 story rectangular 3 x 3 bay frame dwelling w/front-facing gable roof; 2 x 2 bay frame wing at rear 2 bays of E elev.; 1x1 bay rear wing. Roof has 1 historic ridge vent, 1 recent vent, an interior brick chimney, and a boxed cornice w/returns. The upper tier of the porch has been screened. The principal entrance, with transom & sidelights, is located in the E bay of the 1st level of the facade. Remaining bays have single 6/6 double hung sash windows. Side elevations have similar windows. The wing has a side-facing gable roof and a boxed cornice with returns. A former engaged porch at its facade has been infilled.
