**BEAUFORT COUNTY  
HISTORIC SITES SURVEY - 1997**

INTENSIVE LEVEL BUILDING INVENTORY FORM

Site Number: U- 13 - 522  
Access County Site #  
USGS Quad: 025 Beaufort  
Doc. Level: Intensive Level-Building

Historic name(s): \_\_\_\_\_ Map Ref.: PR 12 Tax Number: R110.011.000.0049.0000  
Common name(s): \_\_\_\_\_ City Block Ref.: \_\_\_\_\_ Island: Port Royal Is.  
Address/location: 906 9th St. City/Vicinity of (vic.) Port Royal  
Date: 1915 ca. Alteration date: 1950 ca.  
Ownership:  1. private  2. city  3. county  4. state  5. federal  6. unknown  
Category:  1. building  2. site  3. structure  4. object  
Historic use(s): single dwelling Current uses: single dwelling

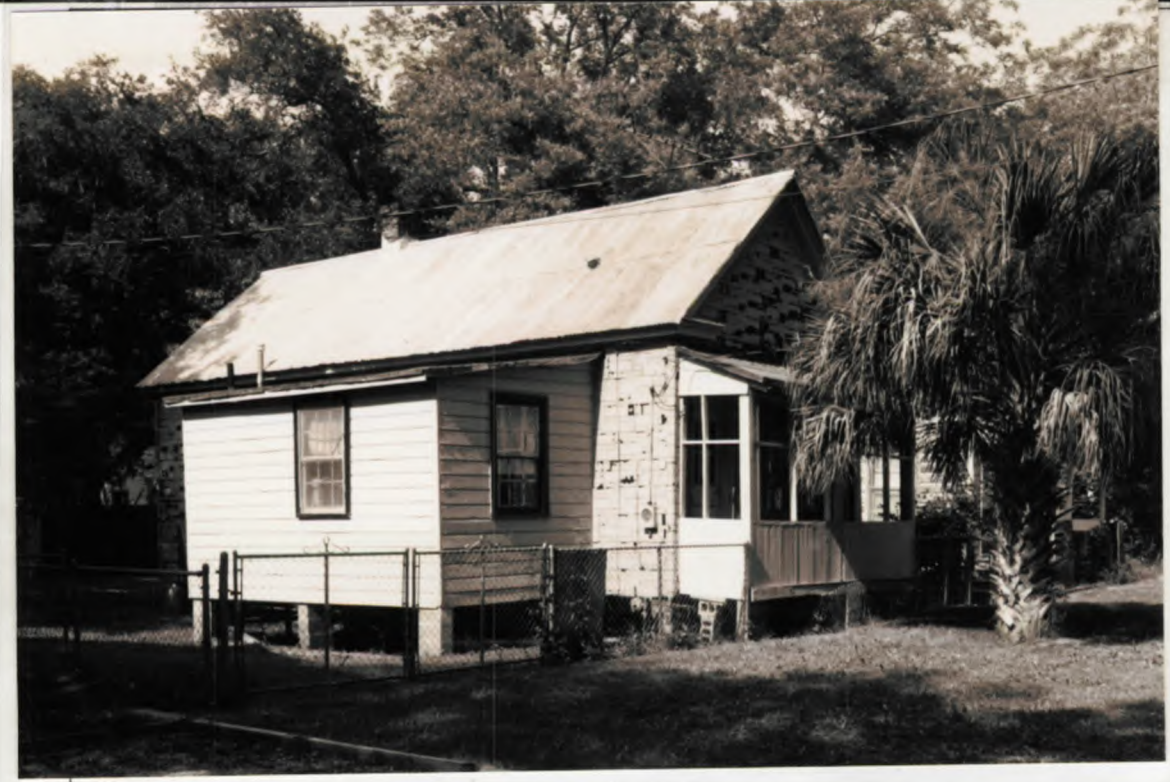
Photograph:

Roll # Neg. View of:  
B-08 27 S facade & W elev., fac. NE

Alterations: Alteration date: 1950 ca. Integrity: fair Condition: good  
 Addition, asphalt siding, porch replacement.

Description: Rectangular 1-story frame 2x3 bay dwelling w/front-facing gable roof; 1x1 bay shed addition at W elev. Boxed cornice w/returns. 1-story full facade porch with apron wall and insect screen farming. Facade has a single entrance in its W bay and a double 6/6 window in its E bay. A recessed porch is located in the 3rd bay (from S) of the E elev. Remaining openings in the side elevation have single 6/6 windows. A 1x1 bay from addition is located at the rear.
