**BEAUFORT COUNTY  
HISTORIC SITES SURVEY - 1997**

INTENSIVE LEVEL BUILDING INVENTORY FORM

Site Number: U- 13 - 523  
Access County Site #  
USGS Quad: 025 Beaufort  
Doc. Level: Intensive Level-Building

Historic name(s): \_\_\_\_\_ Map Ref.: PR 12 Tax Number: R110 011 000 0048 0000  
Common name(s): \_\_\_\_\_ City Block Ref.: \_\_\_\_\_ Island: Port Royal Is.  
Address/location: 904 9th St. City/Vicinity of (vic.): Port Royal  
Date: 1915 ca. Alteration date: 1970 ca.  
Ownership:  1. private  2. city  3. county  4. state  5. federal  6. unknown  
Category:  1. building  2. site  3. structure  4. object  
Historic use(s): single dwelling Current uses: single dwelling

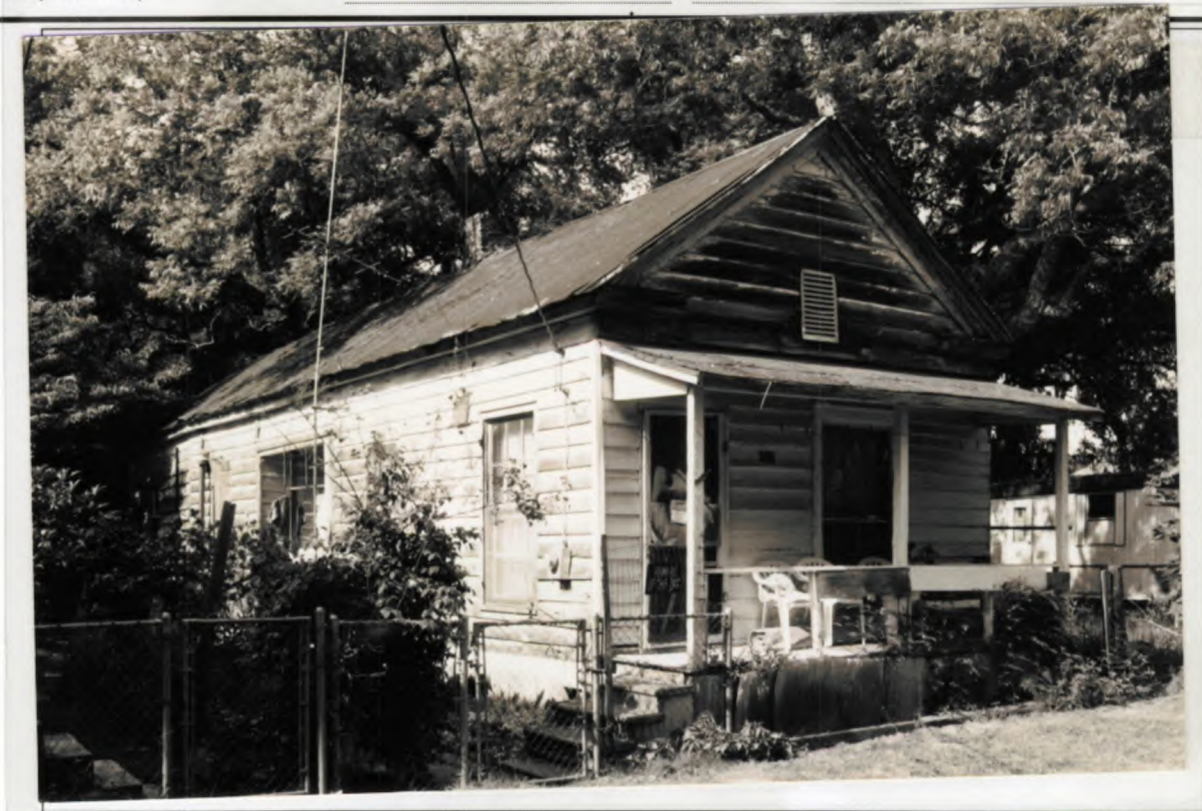
Photograph:

Roll # Neg. View of:  
B-08 28 S facade & W elev., fac. NE

Alterations: Alteration date: 1970 ca. Integrity: good Condition: good  
 Replacement porch posts and railing

Description: Rectangular 1-story frame 2x3 bay dwelling w/front-facing gable roof. Boxed cornice w/returns. 1-story full facade porch with posts and railing. Facade has a single entrance in its W bay and a single 6/6 window in its E bay. A recessed porch is located in the 3rd bay (from S) of the W elev. Remaining openings in the side elevation have single 6/6 windows. A 1x1 bay from addition is located at the rear.
