**BEAUFORT COUNTY
HISTORIC SITES SURVEY - 1997**

INTENSIVE LEVEL BUILDING INVENTORY FORM

Site Number: U- 13 - 539
Access County Site #
USGS Quad: 025 Beaufort
Doc. Level: Intensive Level-Building

Historic name(s): Union Church Map Ref.: PR 11 Tax Number: R110 010 000 0168 0000
Common name(s): Port Royal Playhouse City Block Ref.: Island: Port Royal Is.
Address/location: 1004 11th St. City/Vicinity of (vic.) Port Royal
Date: 1878 Alteration date: 1980 ca.
Ownership: 1. private 2. city 3. county 4. state 5. federal 6. unknown
Category: 1. building 2. site 3. structure 4. object
Historic use(s): church Current uses: single dwelling

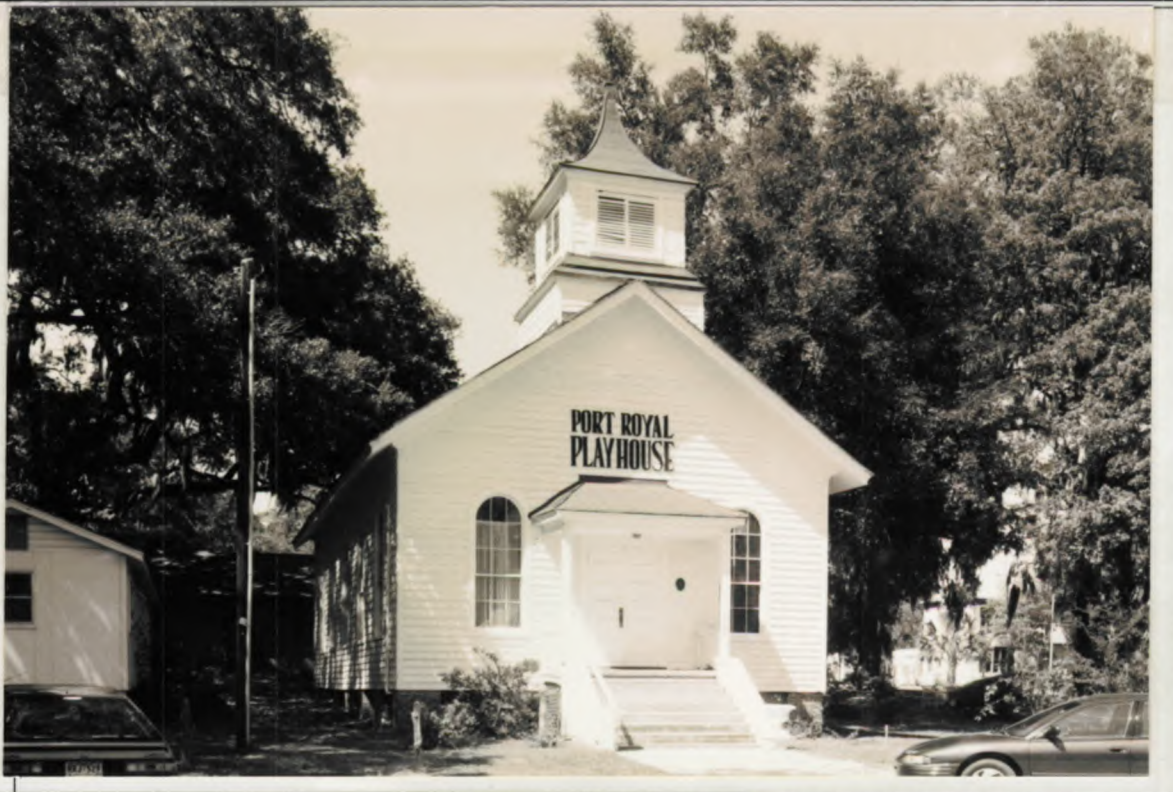
Roll # Neg. View of:
B-01 19 S facade & W elev., fac. NE

Alterations: Alteration date: 1980 ca. Integrity: good Condition: good
 Alterations have typically been limited to the interior during its conversion to a playhouse. Despite these changes, the interior retains good integrity.

Description: Rectangular 3 x 5 bay 1 story frame church w/front-facing gable raised seam metal roof. Roof has two tier bell tower with belcast hipped roof and rectangular louvered vents. 1 story porch at entrance bay with hipped roof. Central entrance with double paneled doors flanked by 9/6 double hung windows w/ arched upper sash. Similar windows are found in all bays of the side elevations. The northern window at the west elev. has been infilled with plywood. The rear has a simply projecting polygonal apse.
