**BEAUFORT COUNTY
HISTORIC SITES SURVEY - 1997**

INTENSIVE LEVEL BUILDING INVENTORY FORM

Site Number: U- 13 - 557
Access County Site #
USGS Quad: 025 Beaufort
Doc. Level: Intensive Level-Building

Historic name(s): _____ Map Ref.: PR 11 Tax Number: R110 010 000 0099 0000
Common name(s): _____ City Block Ref.: _____ Island: Port Royal Is.
Address/location: 1138 13th St. City/Vicinity of (vic.): Port Royal
Date: 1900 ca. Alteration date: 1950 ca.
Ownership: 1. private 2. city 3. county 4. state 5. federal 6. unknown
Category: 1. building 2. site 3. structure 4. object
Historic use(s): single dwelling Current uses: single dwelling

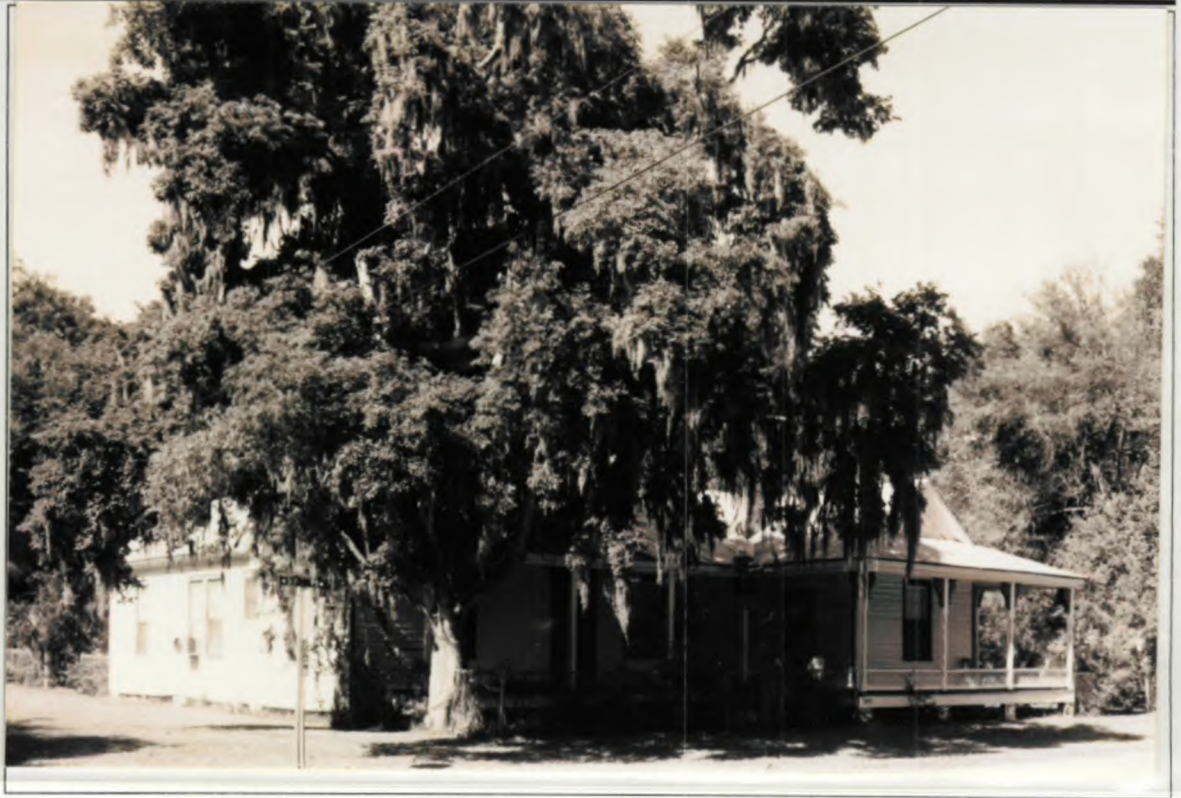
Photograph:

Roll # B-01 Neg. 33 View of: S facade & W elev., fac. NE

Description: L shaped 1 story frame dwelling w/cross gable raised seam metal roof; rear ell wings at E & W sides w/recent infill between. Full facade porch w/chamfered posts , slat balustrade & sawn brackets wraps to 1st 3 bays of E elev. Facade has an entrance in its 2nd bay (from W) and single 6/6 double hung sash windows in remaining bays. W elev. has a central single original 6/6 window and a later small profile 6/6 wind to the N. The W ell has a double 6/6 window in the S bay of its W elev. and a single 6/6 window in the northern bay. The E elev. has an entrance in its center bay flanked by 6/6 windows. There is a small frame shed to the rear of the property.
