**BEAUFORT COUNTY  
HISTORIC SITES SURVEY - 1997**

INTENSIVE LEVEL BUILDING INVENTORY FORM

Site Number: U- 13 - 561  
Access County Site #

Historic name(s): \_\_\_\_\_ Map Ref.: PR 11 Tax Number: R110 010 000 0107 0000  
Common name(s): \_\_\_\_\_ City Block Ref.: \_\_\_\_\_ Island: Port Royal Is.  
Address/location: 1115 14th St. City/Vicinity of (vic.): Port Royal  
Date: 1910 Alteration date: 1950 ca.  
Ownership:  1. private  2. city  3. county  4. state  5. federal  6. unknown  
Category:  1. building  2. site  3. structure  4. object  
Historic use(s): single dwelling Current uses: single dwelling

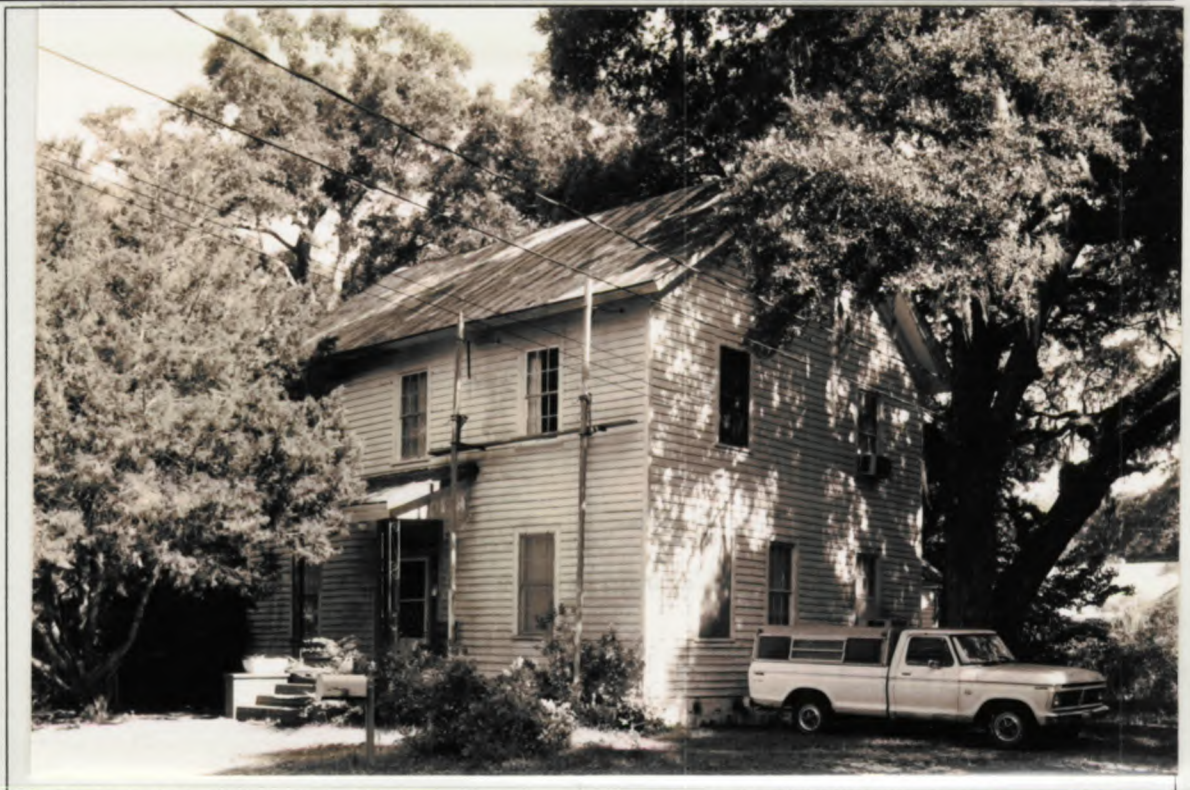
Roll # Neg. View of:  
B-01 36 N facade & W elev., fac. SE

Alterations: Alteration date: 1950 ca. Integrity: good Condition: good  
 Porch posts, brick stoop, infill at porch

Description: Rectangular 2 story frame 3x2 bay dwelling w/lateral gable roof; entrance bay only porch at facade; 1x1 bay gable wing at S end of E elev.; 2-tier porch along rear is partially infilled; 1 story kitchen building at rear-center now attached by infill. Facade has central entrance w/transom & sidelights flanked by single 6/6 windows. 6/6 windows in each bay of 2nd level and at side elevs.
