**BEAUFORT COUNTY  
HISTORIC SITES SURVEY - 1997**

INTENSIVE LEVEL BUILDING INVENTORY FORM

Historic name(s): Porter's Chapel A.M.E. Church Map Ref.: PR 12 Tax Number: R110 011 000 110A 0000  
 Common name(s): \_\_\_\_\_ City Block Ref.: \_\_\_\_\_ Island: Port Royal Is.  
 Address/location: 1515 Old Shell Rd. City/Vicinity of (vic.) Port Royal  
 Date: 1925 ca. Alteration date: 1945 ca.  
 Ownership:  1. private  2. city  3. county  4. state  5. federal  6. unknown  
 Category:  1. building  2. site  3. structure  4. object  
 Historic use(s): church Current uses: church

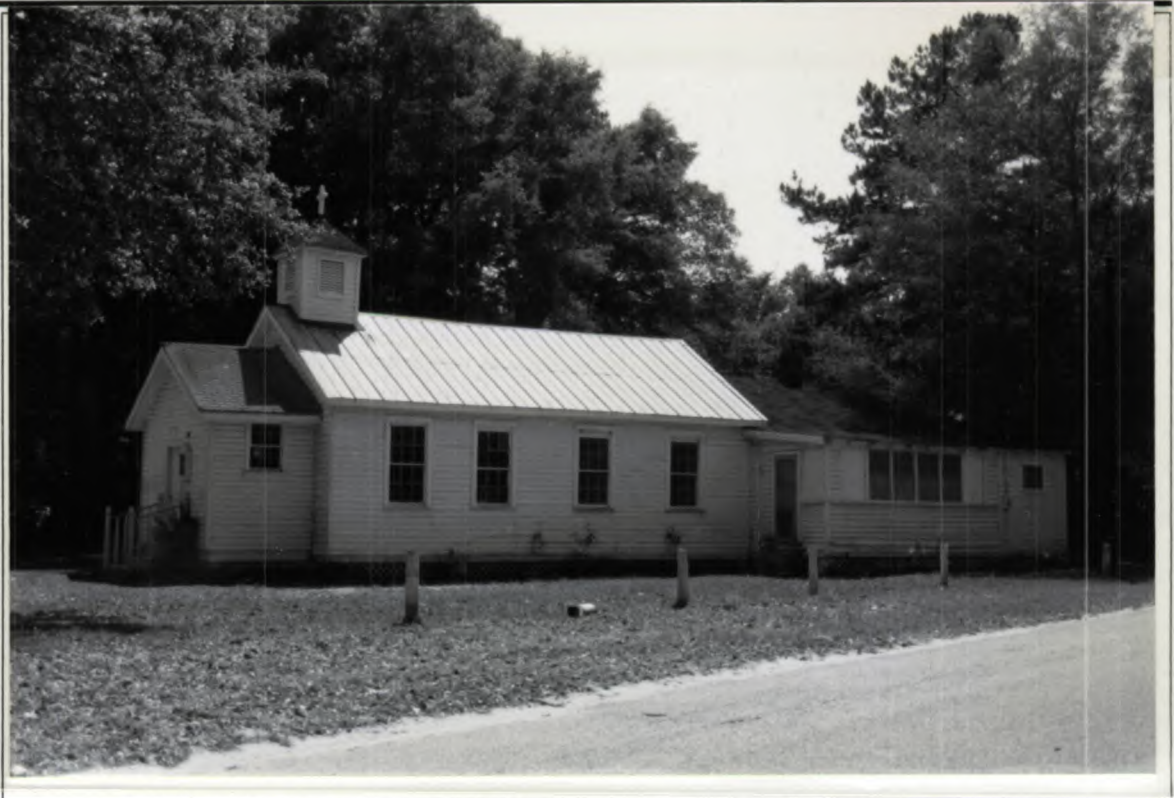
Photograph:

Roll # Neg. View of:  
 S-01 20 E facade & N elev., fac. SW

Alterations: Alteration date: 1945 ca. Integrity: good Condition: good  
Porch infill & rear addition

Description: 1 story rectangular 1 x 4 bay frame church building w/front-facing gable roof; 3 x 1 bay rear addition w/gable roof, 1 story enclosed porch at N side. Small rectangular bell tower at front of roof ridge has hipped roof & rectangular louvered vents. Former porch at facade now infilled. Side elevs. have 6/6 double hung sash windows in all bays.
